PRODUCT CAMPAIGN BULLETIN

APPLICABILITY: 2012 MY Impreza (except WRX/STI)

NUMBER: WQT-55

SUBJECT: Occupant Detection System (ODS)
 Occupant Control Unit (OCU)

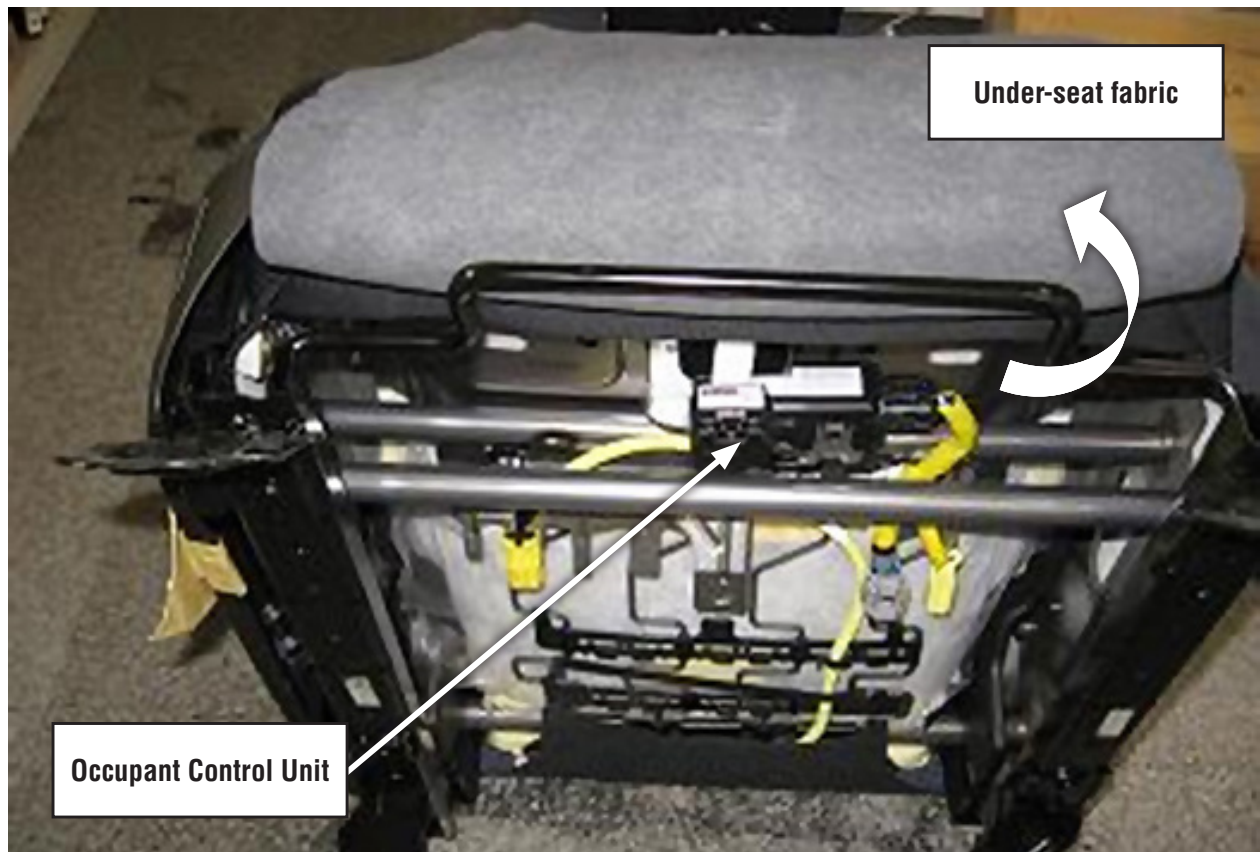
Remove the clip that secures the under-seat fabric covering the OCU and flip the fabric over.

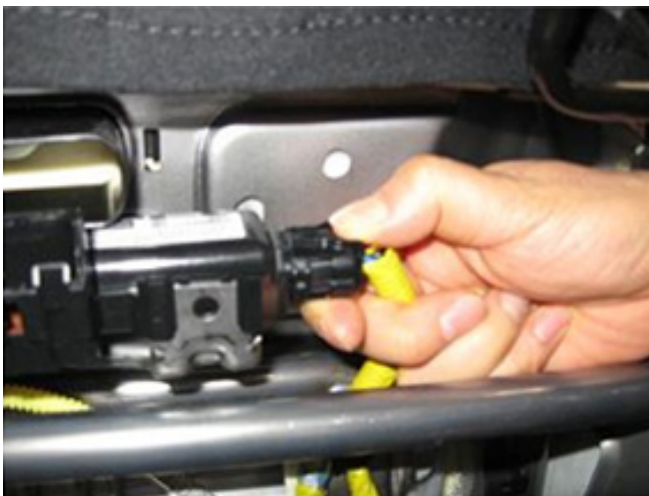
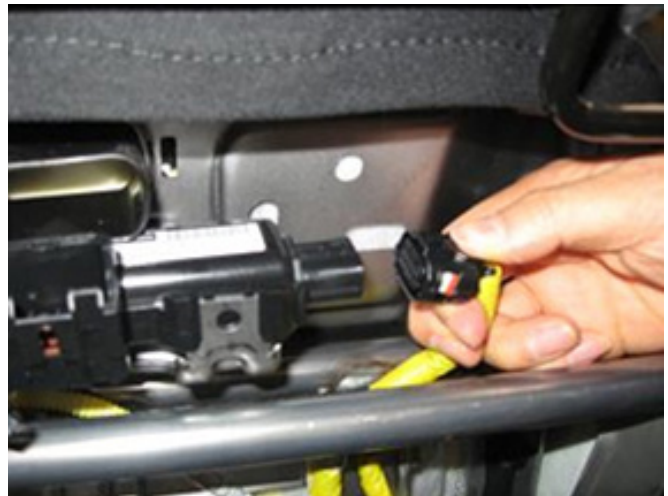
Disconnect the intermediate body wiring harness connector from the OCU.

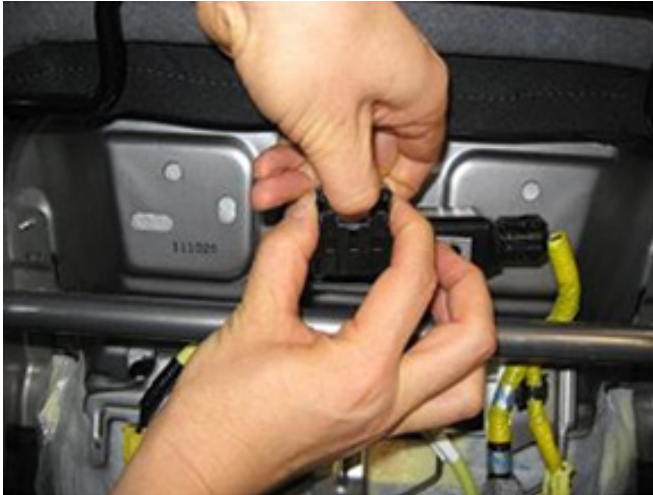
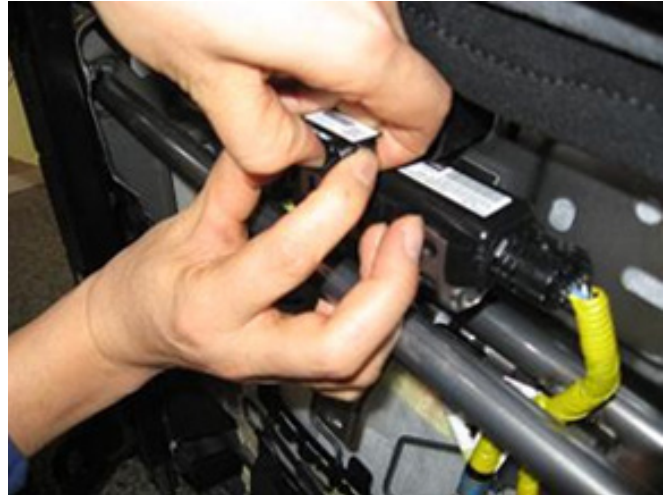
CAUTION: Safety glasses should be worn during the removal process.
Carefully remove the Mat Sensor wiring harness connector from the OCU.

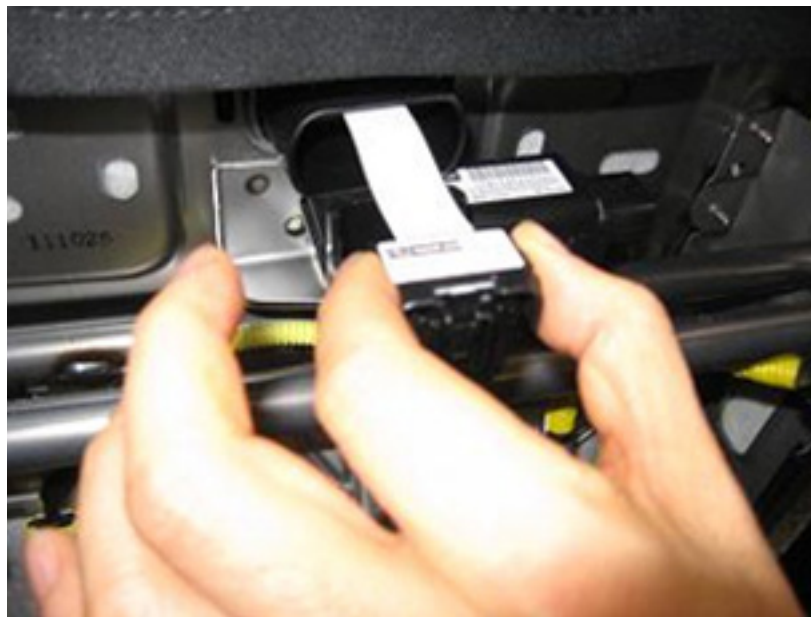
NOTE: The Mat Sensor wiring harness is a ribbon type and can be damaged easily if mishandled.

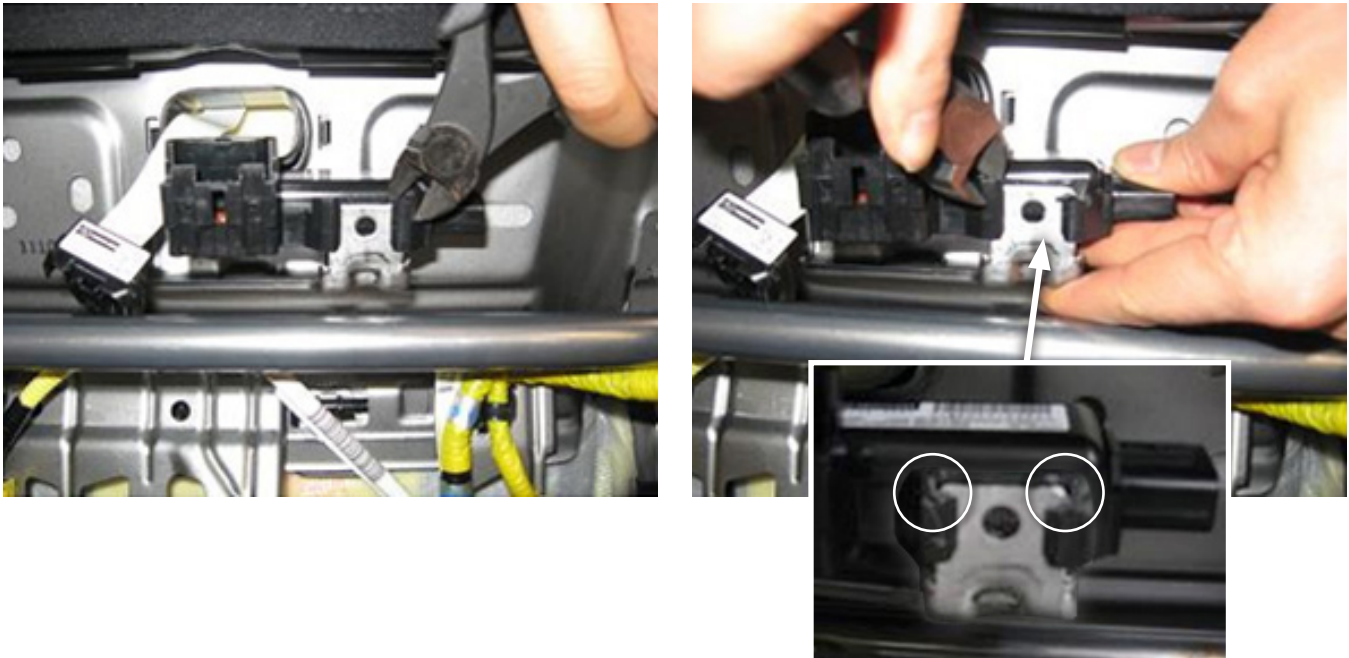
Use diagonal pliers and break off the holding portions on the OCU body.

NOTE: Be careful not to cut or distort the bracket.

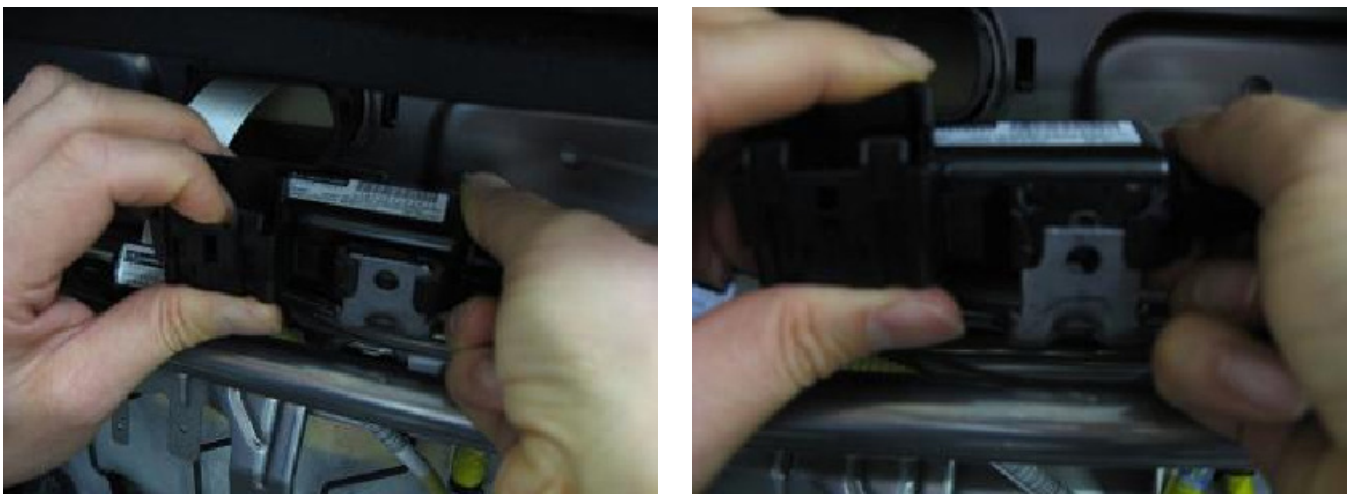
Use a slight twisting motion to disengage the OCU from the bracket.

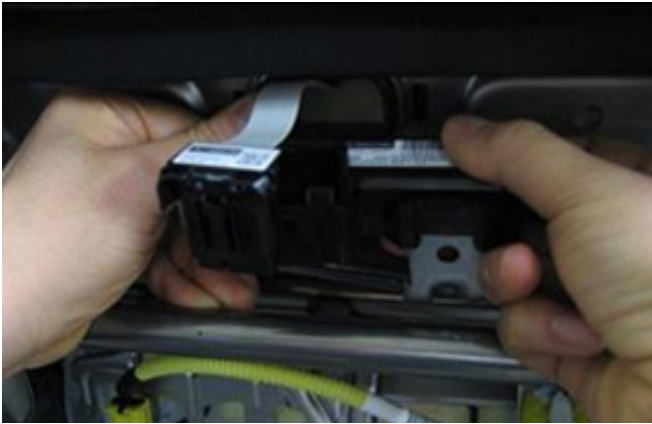
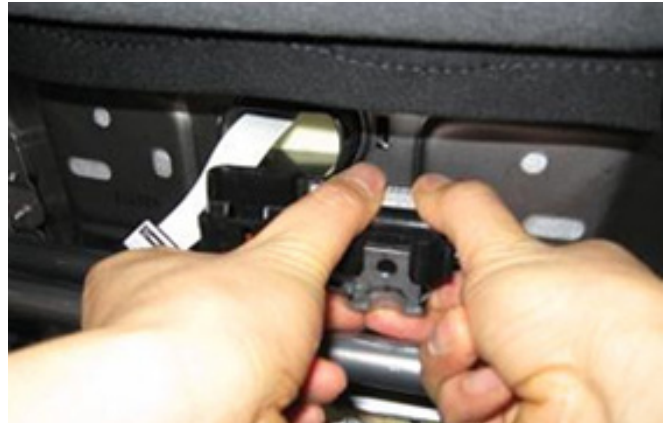
Install the new OCU onto the bracket; make sure it is properly seated (you should hear a snapping sound).

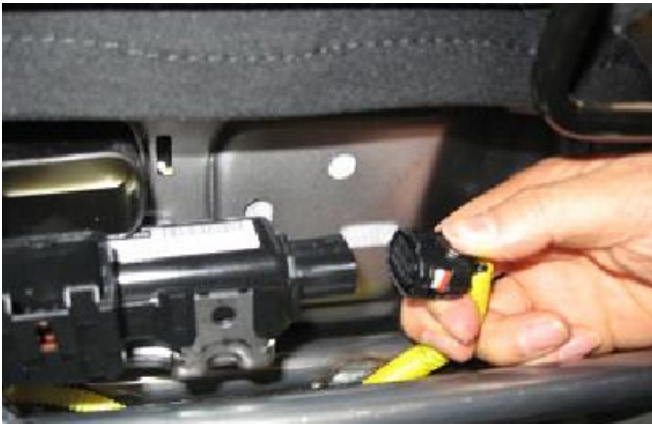
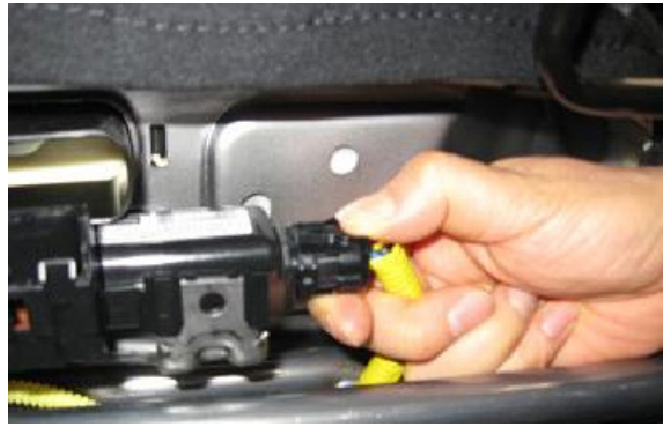
Connect the intermediate body wiring harness connector to the OCU.

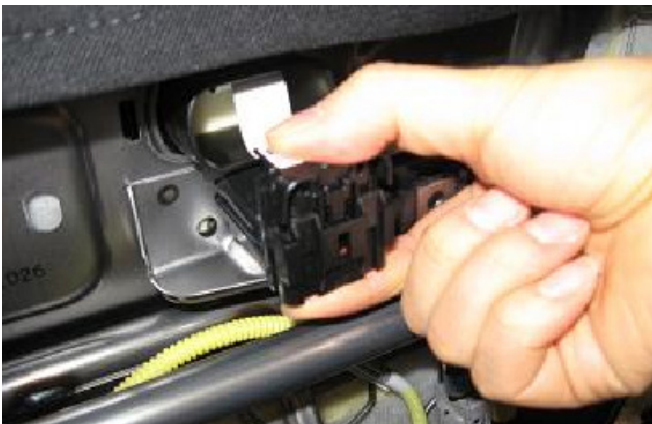
Connect the Mat Sensor wiring harness connector to the OCU.

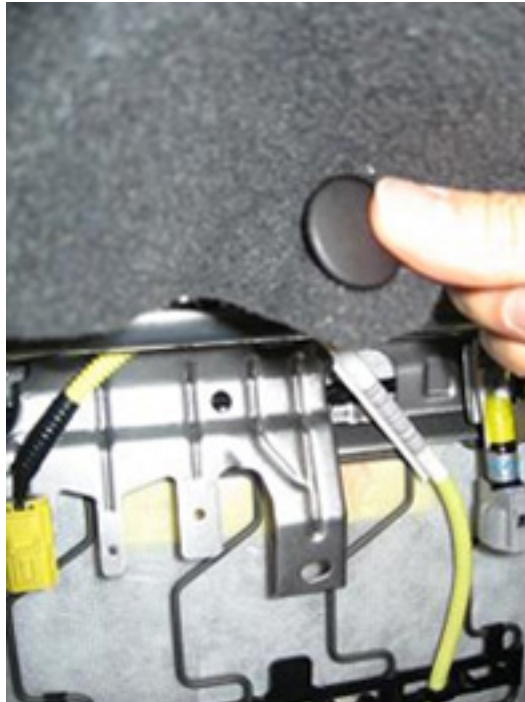
Flip the under-seat fabric back to the original position and install the clip.
