## SERVICE BULLETIN

**APPLICABILITY:** 2015MY WRX

**NUMBER:** 07-95-15

**SUBJECT:** Design Change to Engine Wiring Harness

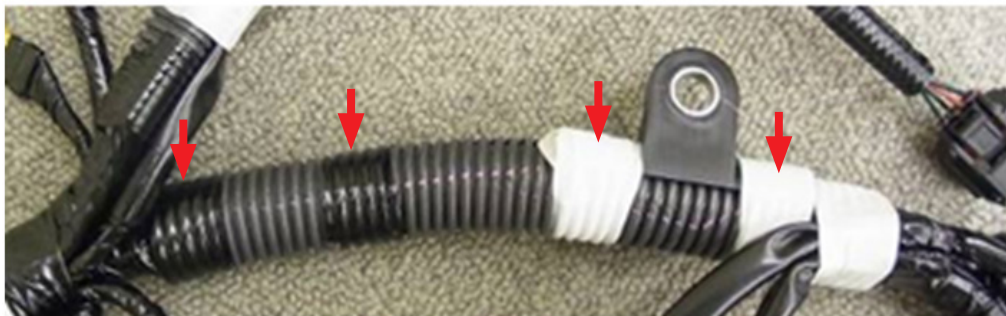
**PITCH TAPING**

This Service Information bulletin announces a design change to the engine wiring harness to prevent water intrusion and accumulation from occurring inside the corrugated plastic harness tubing. In some cases, this accumulation may cause a Check Engine Light to illuminate and exhaust camshaft position-related DTCs to be stored in the ECM memory (e.g. P0390, P0391). The change involves full taping of the harness tube as opposed to pitch taping (no tape overlap) to enhance “sealing” of the harness tube and prevent water intrusion which may occur during engine cleaning (steam cleaning and / or pressure washing). Under normal driving conditions, there is no possibility of this condition occurring. Comparison photos of the taping are shown below for reference.

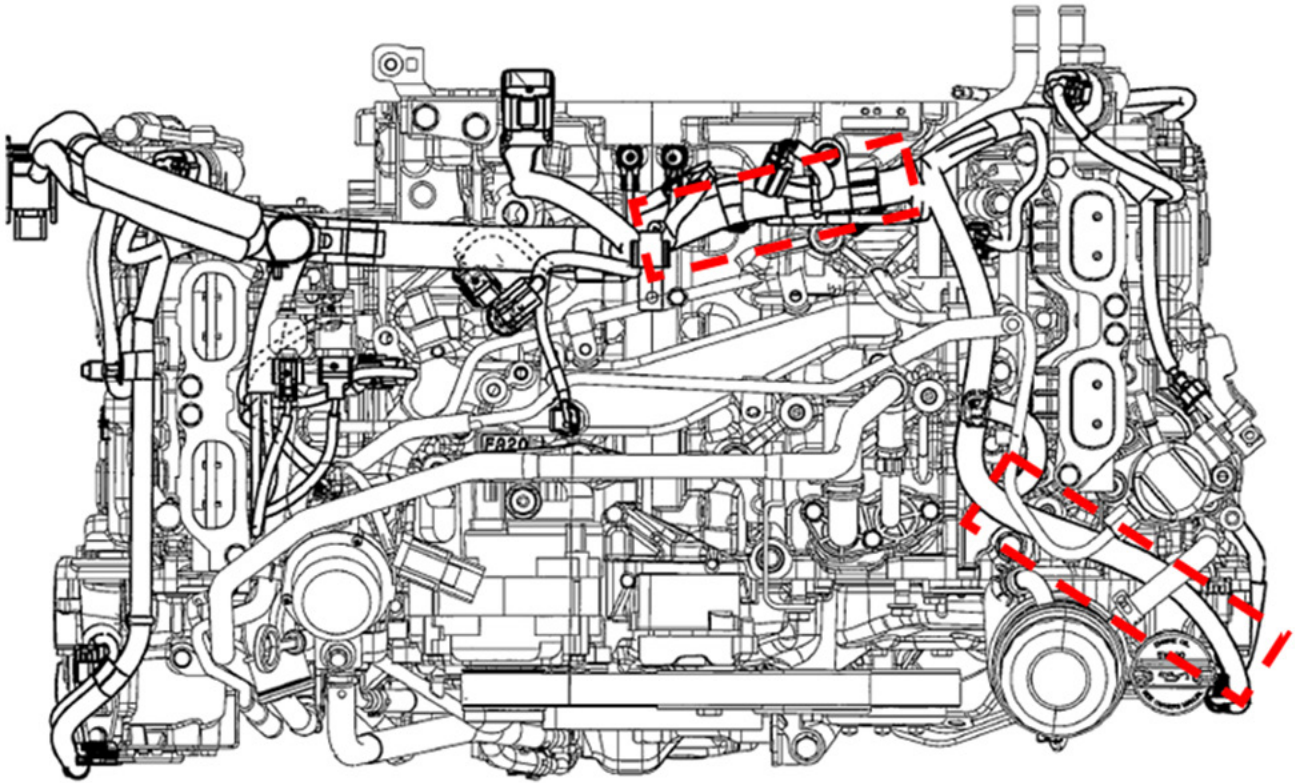
Areas of the new engine harness where full taping is now utilized are outlined in red as shown below.

The part number for the new engine harness is **24020AF981**.

When electrical diagnostics have isolated the root cause of failure to be a fault within the engine harness which cannot be repaired, replace it with the part number shown above.
