**SERVICE BULLETIN**

**APPLICABILITY:** 2014-15MY Forester Models Equipped with EyeSight **NUMBER:** 07-97-15  
**SUBJECT:** Procedure Change when EyeSight Stereo Camera Cover Finish Is Peeling **DATE:** 08/10/15

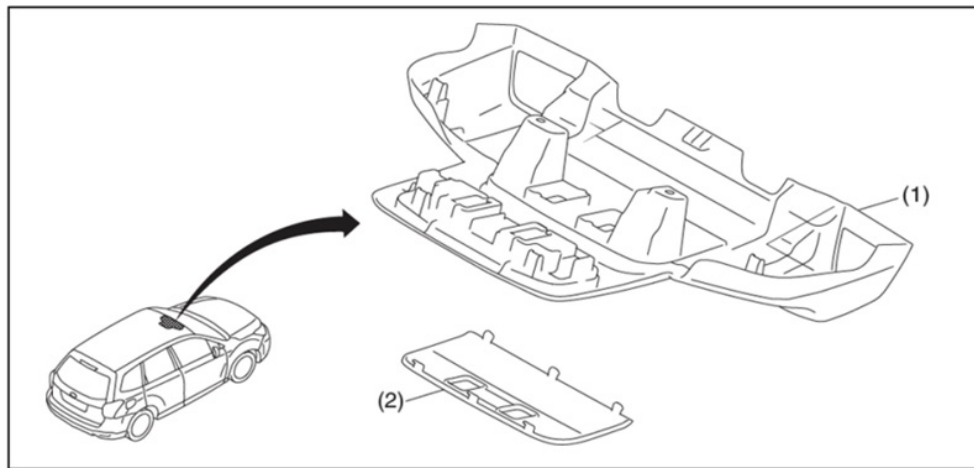
There have been a small number of reports stating the finish of the EyeSight stereo camera trim cover is peeling. This bulletin announces a change to the paint material to eliminate the condition and instructions for ordering the replacement parts.

(1) Stereo camera cover ASSY (2) Cap ETC

**IMPORTANT:** When ordering a replacement cover or cap for a vehicle with a VIN PRIOR to the production change listed above, both parts in the table above must be ordered / replaced as a set to insure proper color match.
