SERVICE BULLETIN

APPLICABILITY: 2015MY Legacy, Outback, Impreza & XV Crosstrek **NUMBER:** 15-182-15R
 2016MY WRX **DATE:** 06/17/15
 Models with Fujitsu-Ten (F10) Navigation System **REVISED:** 08/11/15

SUBJECT: Procedures for Updating the Head Unit Operating Software

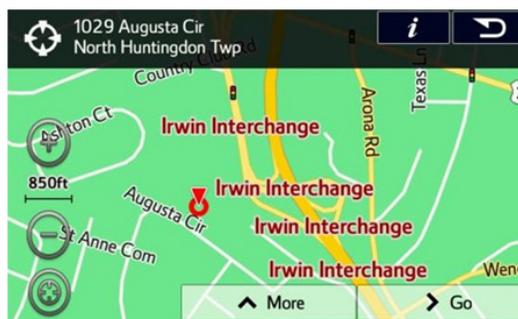
- **Symptom 6:** Roads or interchanges have the same name displayed multiple times.

Change: Logic change to show only one road or interchange name at the same time. *Continued...*

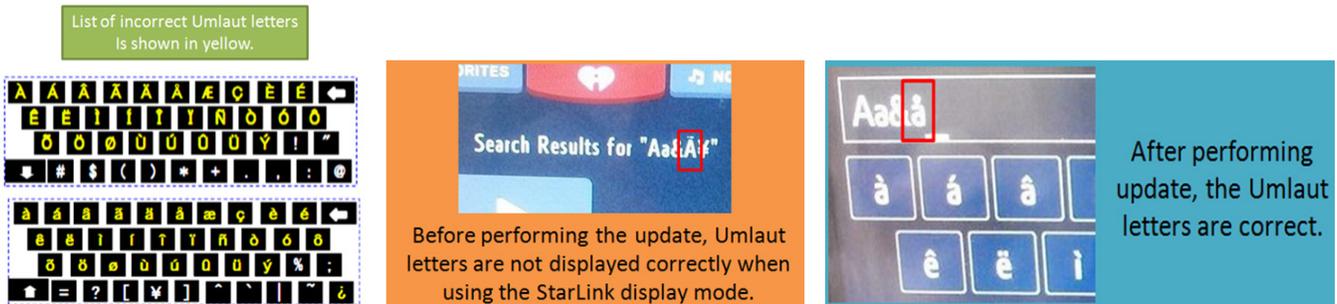
- **Symptom 7:** Navigation function is slow to start when selected.
Change: Logic change to eliminate Navigation system slow-starting condition.
- **Symptom 8:** No map display with key or ignition in “ACC” (accessory) position.
Change: Logic change to allow Navigation system operation in accessory ACC mode.
- **Symptom 9:** No voice guidance provided from Navigation system after selecting a route unless the ignition is cycled off and back on again.
Change: Logic change to stop voice guidance “Mute” function from defaulting to “ON”.
- **Symptom 10:** Steering wheel switch controls are inoperative with an iPod (MP3) player connected to the USB.
Change: Logic change to allow proper steering wheel (satellite) switch functionality.
- **Symptom 11:** Incorrect Umlaut characters are shown on StarLink display.

Change: Logic change to allow proper display of Umlaut letters.

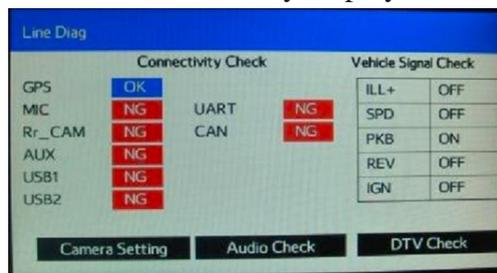
- **Symptom 12:** No response from the soft touch keys on display.
Change: Logic change to improve communication between display and internal CPU.
- **Symptom 13:** Back-Up Camera is displayed with shifter in positions other than Reverse.
Change: Logic change to allow display with shifter in Reverse only.
- **Symptom 14:** “Line Diag” screen is intermittently displayed while driving.

Change: Logic change to prevent display of the “Line Diag” screen.

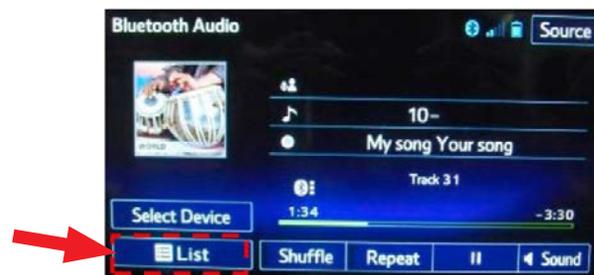
- **Symptom 15:** “LIST” soft touch key is not displayed on Bluetooth Audio screen while using Bluetooth audio feature with an Apple device utilizing iOS8 software version.

Change: Logic change to enhance compatibility with iOS8 software.

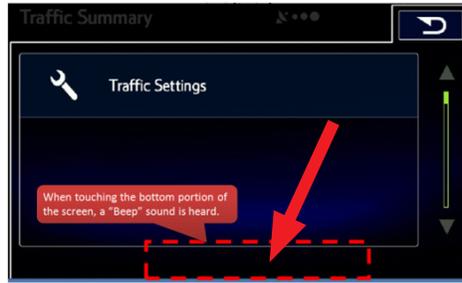
- **Symptom 16:** “Beep” sound heard when touching the bottom of the display screen where no function soft touch keys are displayed.

Change: Logic change to eliminate beeping sound from inactive soft touch key screen areas.

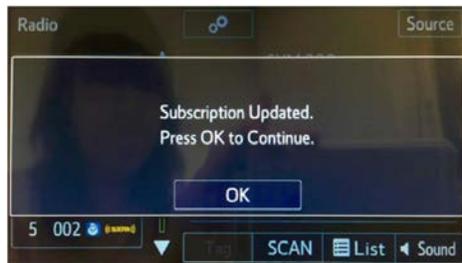
- **Symptom 17:** Sirius/XM caution message screen is displayed in English even when French language operation settings are selected.

Change: Logic change to make all messages display in the selected operating language.

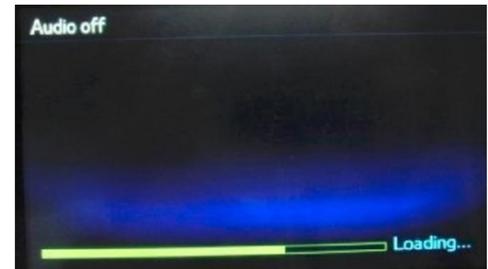
Loading Screen

- **Symptoms 18-22:** The following symptoms are all related to the inability of the software to properly load. One or all of these 5 conditions may occur at the same time.. Logic changes have been included in the applicable update to address each of the following conditions:
 - Repeated display of the “Loading” screen at initial unit start-up
 - Bluetooth device pairing failure
 - Inoperative steering wheel (satellite) switches
 - Voice recognition feature inoperative
 - Sirius/XM radio feature inoperative.
