SERVICE INFORMATION

APPLICABILITY: 2013-15MY BRZ

NUMBER: 12-180-15

SUBJECT: Change to Door Glass Retaining Bolts

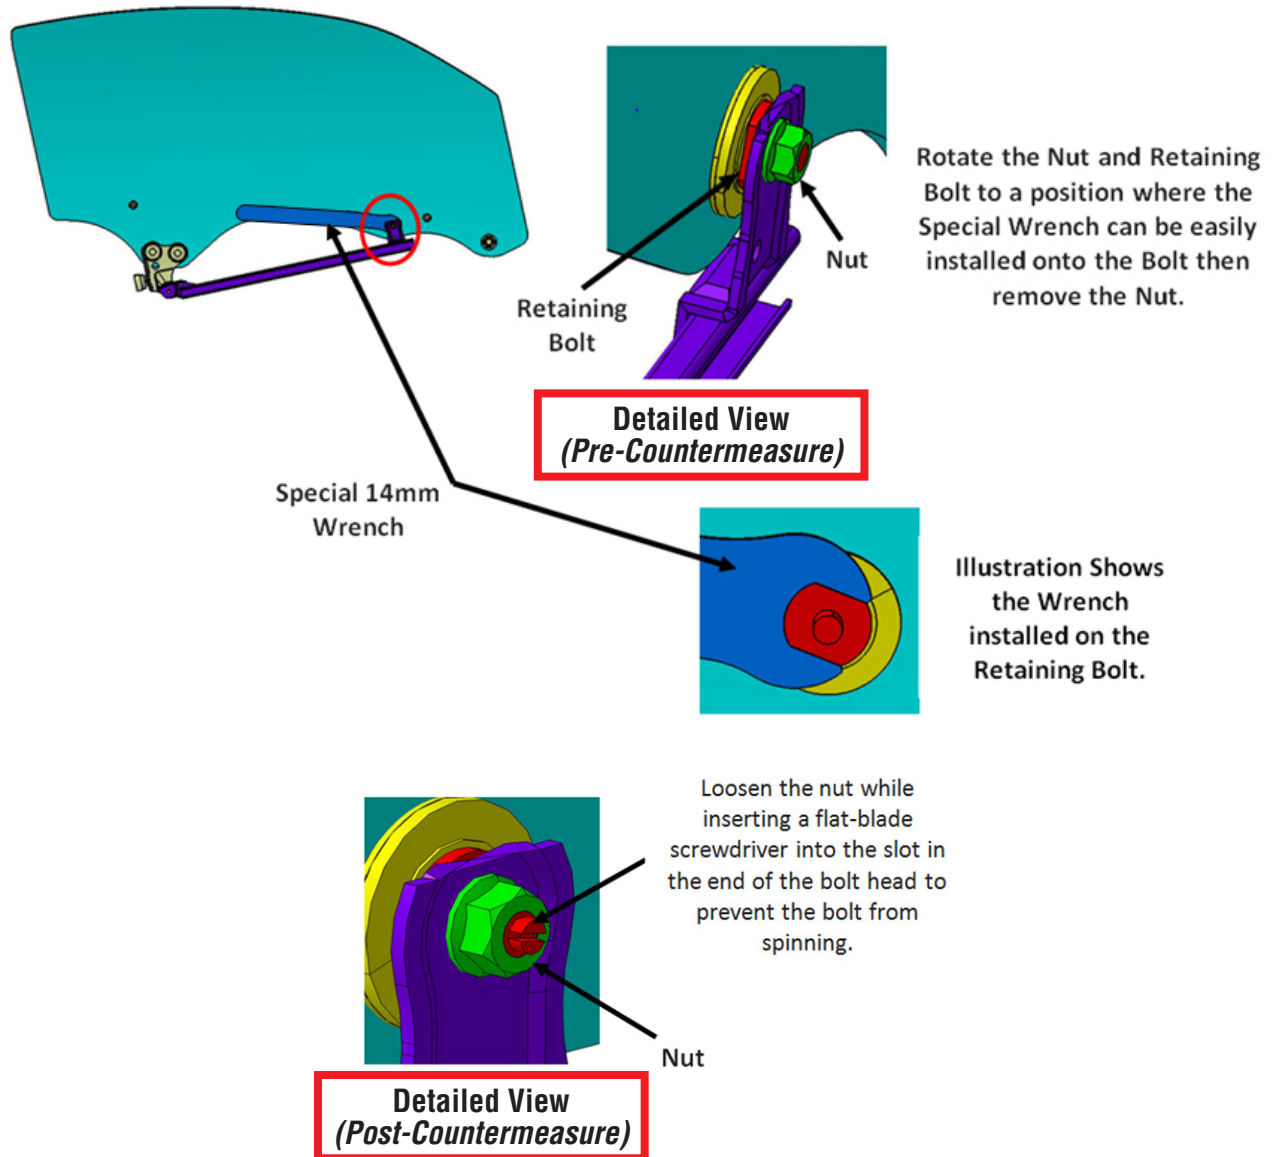
This Service Information bulletin announces a change to the retaining bolt securing the door glass to the window regulator assembly. A slot to accept a flat-blade screw driver has been added to the end of the bolt to keep it from spinning while removing the retaining nut during door glass assembly R&R.

The illustrations below show both the pre and post-countermeasure glass retaining bolt.

- Follow the window glass replacement and adjustment procedures outlined in the applicable Service Manual.
