**PRODUCT CAMPAIGN BULLETIN**

**APPLICABILITY:** 2003-2005 Subaru Legacy and Outback  
 2003-2005 Subaru Baja  
 2004-2005 Subaru Impreza  
 (including WRX and STI)

**NUMBER:** WQP-51R  
**DATE:** January 2015  
**NHTSA ID:** 14V-763  
**REVISED:** August 24, 2015

**SUBJECT:** Regional Front Passenger Air Bag Inflator Replacement

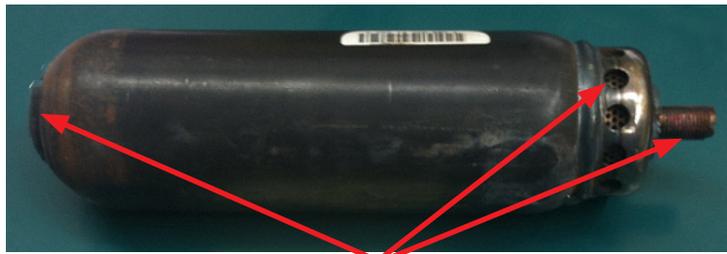
The shape, holes, and copper-colored stud indicate this not a Genuine Subaru inflator.

- **Do not proceed with this repair if your inspection reveals a non-Genuine Subaru air bag module has been installed in the vehicle.** Follow the instructions described in the “Counterfeit Air Bag Information” Dealer Advisory Bulletin and contact the SOA Warranty Helpline to close out the recall coverage on the vehicle.

- Document the presence of the aftermarket or counterfeit device on the repair order and with photos. Report this information immediately on a Quality Monitoring Report (QMR).

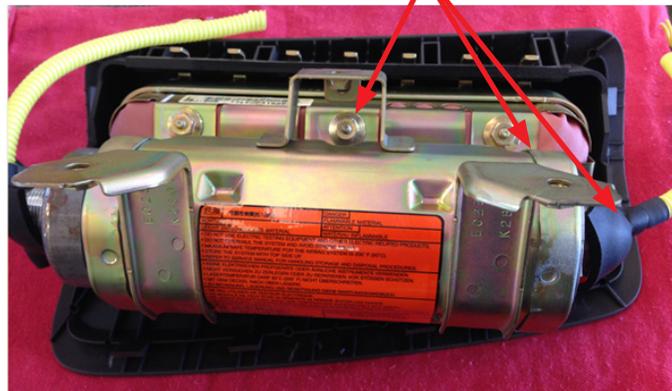
No visible stopper plates, a 6-nut configuration and rubber harness boots are other examples to indicate this is not a Genuine Subaru airbag module.
