## PRODUCT CAMPAIGN BULLETIN

**APPLICABILITY:** 2003-2004 Subaru Legacy and Outback  
 2003-2004 Subaru Baja  
 2004 Subaru Impreza  
 (including WRX and STI)

**NUMBER:** WQL-48R

**SUBJECT:** Front Passenger Air Bag Inflator Replacement

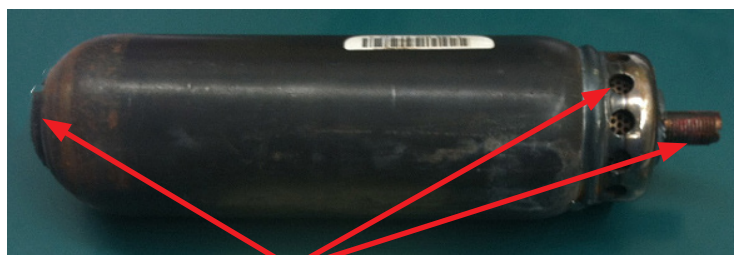
The shape, holes, and copper-colored stud indicate this not a Genuine Subaru inflator.

- If an aftermarket or counterfeit passenger airbag or inflator is identified at any point during the campaign service procedure, **STOP IMMEDIATELY. NEVER attempt to remove or otherwise disable any aftermarket or counterfeit device.**

- Document the presence of the aftermarket or counterfeit device on the repair order and with photos. Report this information immediately on a Quality Monitoring Report (QMR).

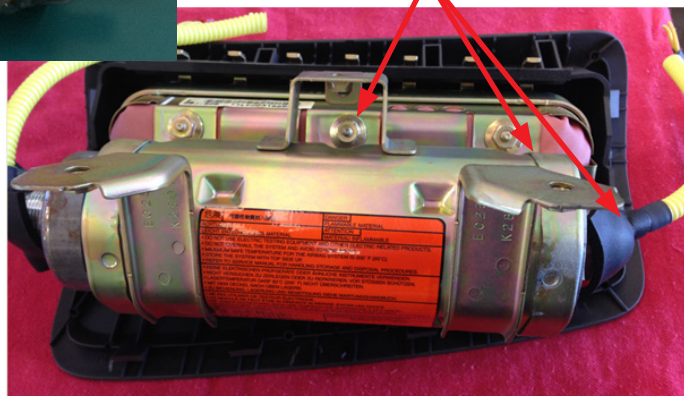
No visible stopper plates, a 6-nut configuration and rubber harness boots are other examples to indicate this is not a Genuine Subaru airbag module.
