SERVICE BULLETIN

APPLICABILITY: 2012-14MY Impreza 2.0L Models
 2015MY WRX and STI Models

NUMBER: 12-189-15
DATE: 09/23/15

SUBJECT: Rattling Sound from Rear Package Shelf Area

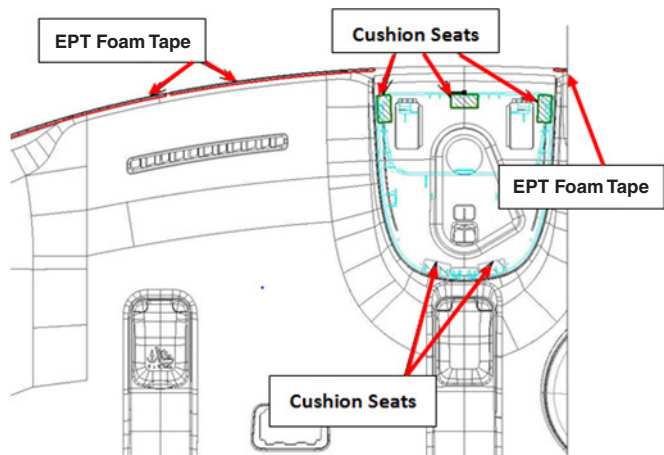
- addition of 5 non-woven tape “cushion seats” in the area of the center stop lamp
- EPT foam tape added along the rear edge of the shelf to insulate it from contacting the rear glass.
