NUMBER: 06-46-14R

SERVICE BULLETIN

SUBJECT: Revised Brake Light Switch Adjustment Procedure

for DTCs C1531 and C0054

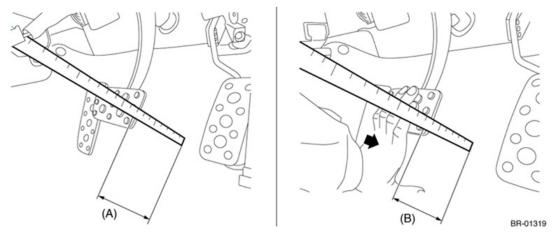
The specification for pedal stroke to activate the BLS is 5.5mm +/- 2.5mm (>3mm but <8mm).

- If the measurement (switch activation) is out of specification, the BLS will need to be adjusted. When the brake lights come on too soon (not enough pedal stroke), the BLS needs to be adjusted "inward" toward the bulkhead while if the pedal stroke is excessive before the brake lights come on, the BLS will need to be adjusted outward toward the steering wheel. The BLS adjustment is sensitive and in most cases, moving it just one notch should bring the operation into specification since one notch is equivalent to approximately 4mm of movement.

2. As shown in the next illustrations, measure the brake pedal stroke by first measuring the distance "A" between the floor mat and the pedal. Depress the brake pedal slowly until the brake lights come on "B" then record the second measurement. Subtract "B" from "A" to obtain the pedal stroke measurement.
