SERVICE BULLETIN

APPLICABILITY: 2015MY WRX and STI Models
 2013-15MY BRZ

NUMBER: 12-190-15
DATE: 10/14/15

SUBJECT: Elimination of Creaking Sound from Clutch Pedal Assembly

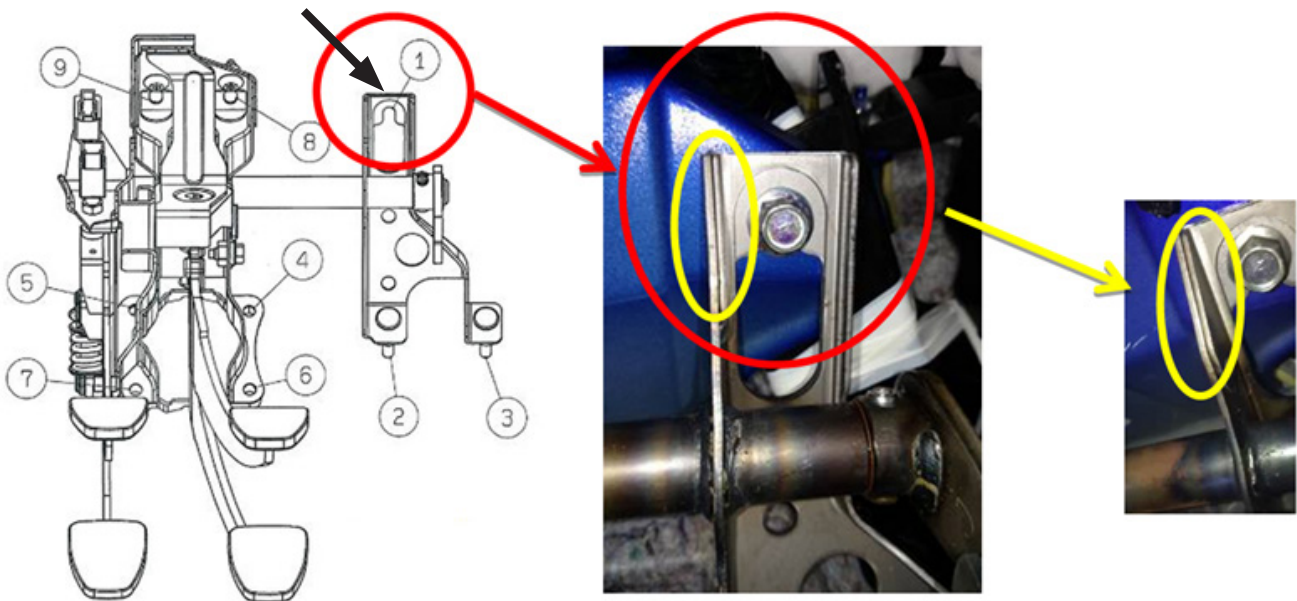
This bulletin provides a procedure to address customer concerns of a creaking sound heard when operating the clutch pedal. The cause of the sound has been identified as a very slight amount of movement between the 2 layers of metal (circled in yellow) which form the specific clutch and brake pedal assembly mounting bracket shown in the illustration and photos below.

- If the sound is unchanged with the screw driver in place, the source is likely to be located elsewhere.
- If the sound is eliminated or changed with the screw driver in place, order the applicable replacement pedal assembly from the parts table provided above.

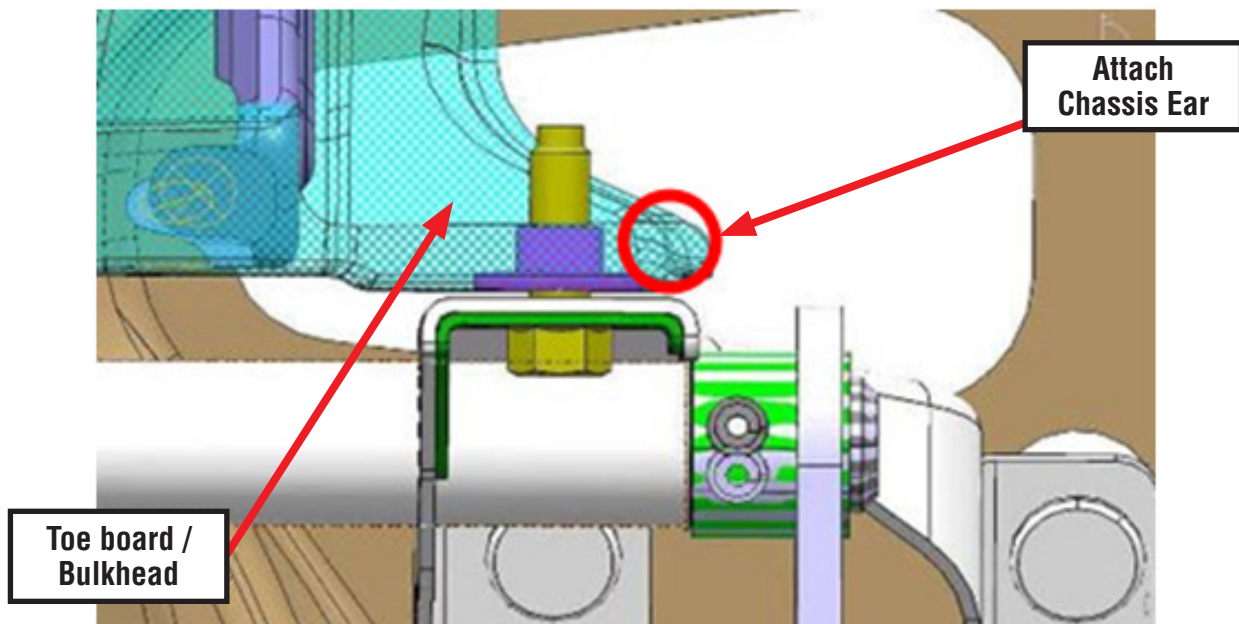
Once the sound has been verified, attach a chassis ear to the toe board / bulkhead in the location circled in the illustration below then operate the clutch pedal.

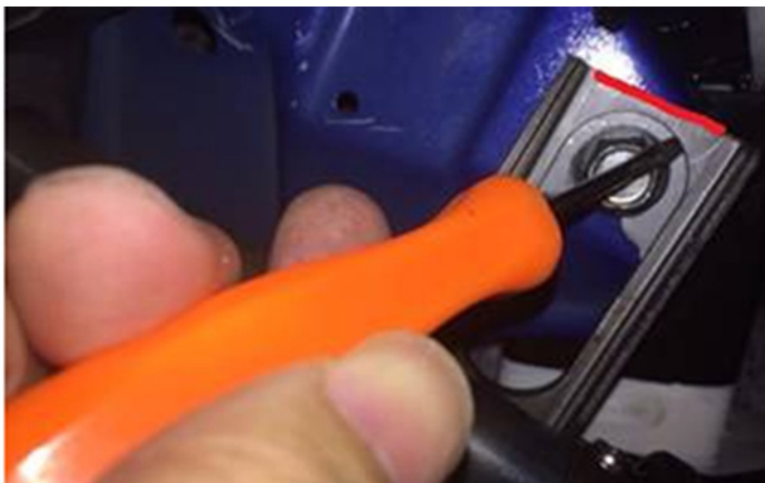
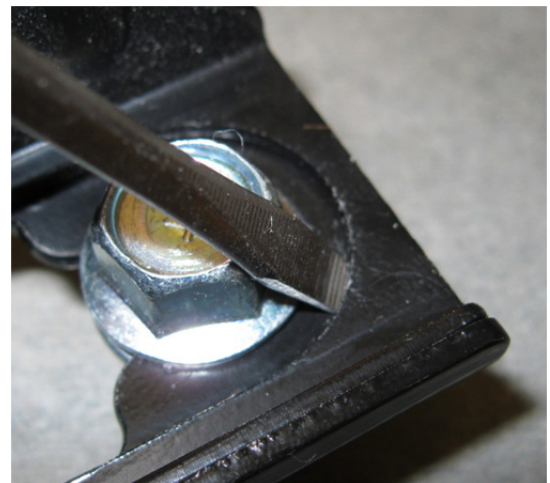
If the sound is confirmed to be originating from that location, use a small flat-blade screw driver to prevent movement of the upper layer while slightly separating it from the lower layer of the bracket as shown in the photo below. Operate the clutch pedal again and with the chassis ear in the same position as before, determine if the sound is changed or reduced while the screw driver is in place.
