SERVICE BULLETIN

APPLICABILITY: 2015MY Outback Models

NUMBER: 12-193-15

SUBJECT: Design Change to Rear Seat Backrest Striker

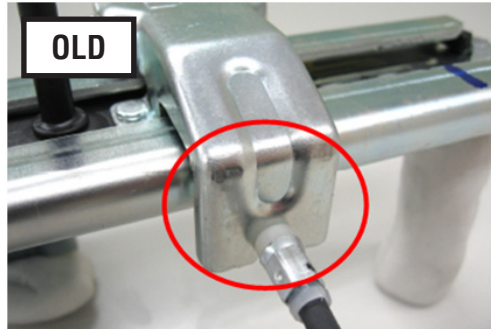
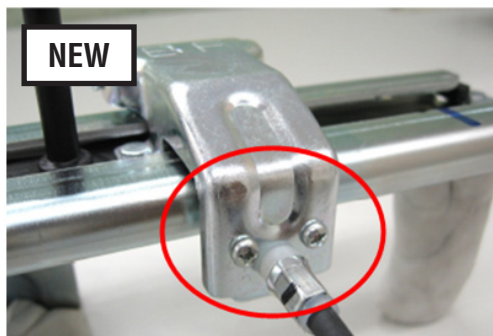
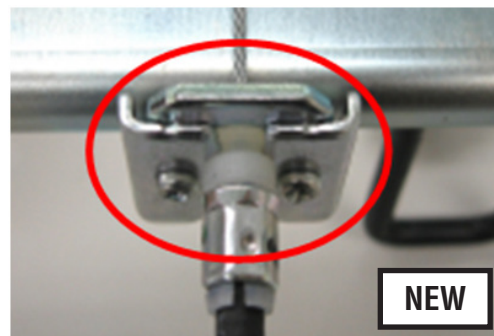
This bulletin announces a design change to the rear seat backrest striker assembly. Prior to this change, if excessive force were to be applied to the reclining lever, the release cable could have become dislodged from the striker mechanism.

The photos below show the difference between the “old” part and the “new”. The new striker assembly incorporates an additional bolted-in retaining bracket to enhance retention of the cable.

NOTE: If the cable becomes dislodged from the striker assembly, do not try to reconnect it. Replace the striker assembly.

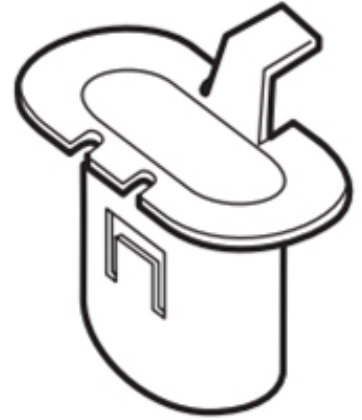
IMPORTANT REMINDER: Whenever removing the rear seat cushion assembly, if any of the white plastic retaining hooks shown in the illustration to the right become dislodged from the body, they **MUST** be replaced to insure proper retention after reinstallation.
