## SERVICE BULLETIN

**APPLICABILITY:** 2016MY WRX and STI Models **NUMBER:** 07-99-15  
**SUBJECT:** Reprogramming File Availability for Keyless Buzzer Volume **DATE:** 10/26/15

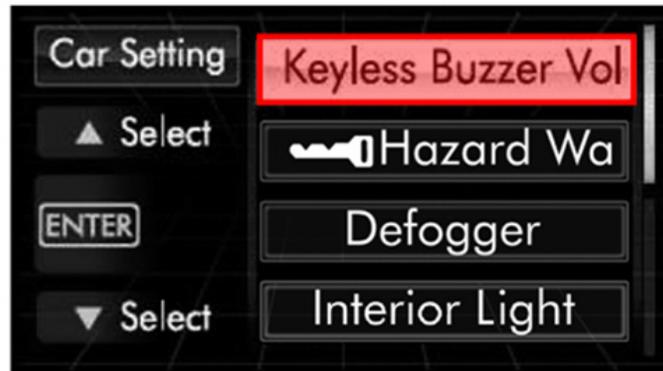
On some vehicles, a customer may not be able to access the “Keyless Buzzer Volume” function on the Multi-Function Display (MFD). This bulletin announces availability of reprogramming files for the Body Integrated Unit (BIU) to facilitate setting the volume of the keyless buzzer via the MFD.

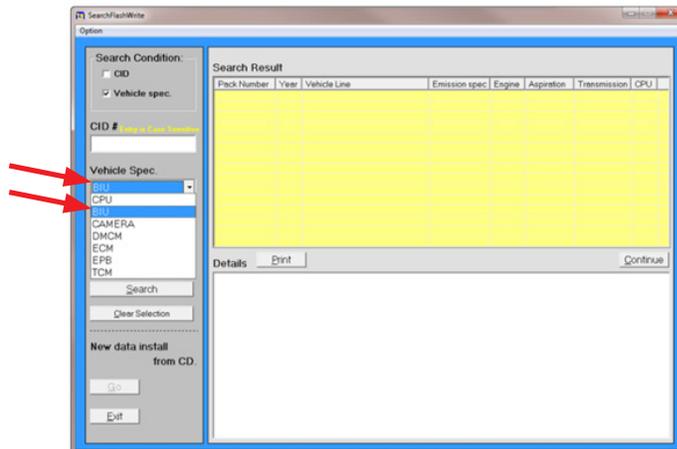
This bulletin is the first for BIU reprogramming. When performing this update, you will notice some small differences in the Flashwrite screens. First, when entering your Vehicle spec. search criteria, BIU has been added to the CPU selection list.

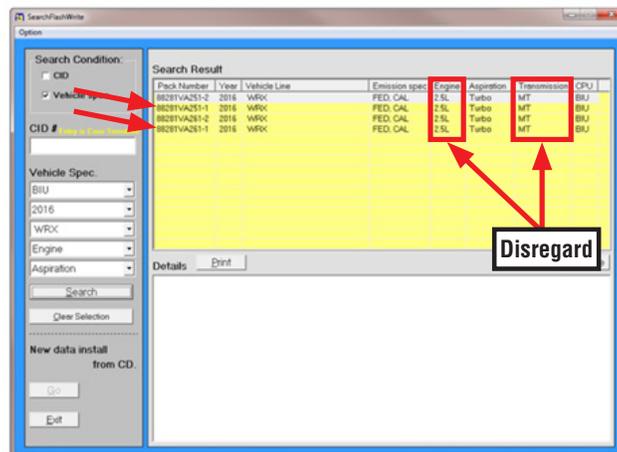
- After making your selections and clicking on Search, the Result will list 4 available Pack files:

**IMPORTANT NOTE:** Currently, 2 of the 4 files listed for this Search Result are for Canada-spec. vehicles and 2 are for US-spec. In addition, for this update, Engine and Transmission types can be disregarded.

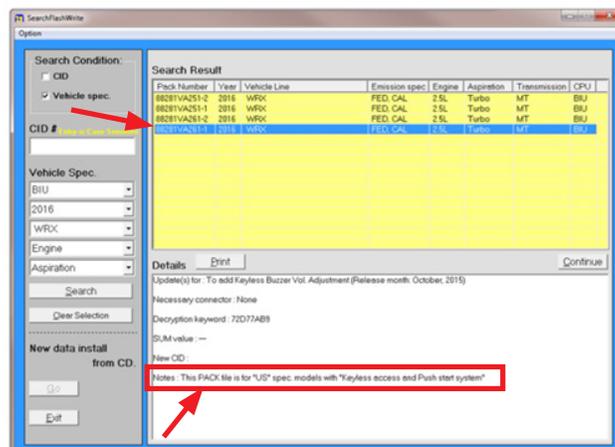
- The 2 files to be used for US-spec vehicles are 88281VA251-1.pak and 88281VA261-1.pak. Pay close attention to the applicability (with or without Keyless access) listed in the “Notes:” listed for each file in the details area of the Search Result screen before making your selection. If you attempt to install the wrong file for the vehicle, an error message will be displayed on the SSM.

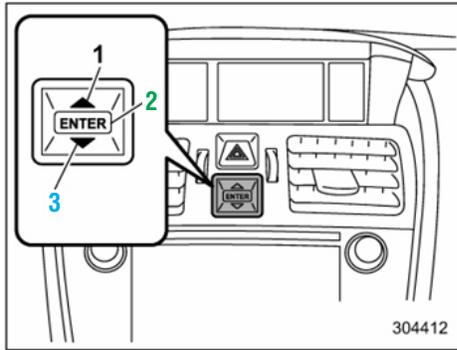
- After reprogramming is done, complete the procedure by confirming proper MFD operation following the screen shot sequence below. Push Up or Down on the ENTER button to scroll then push the ENTER button in to make (enter) your selection.

Control Switch  
 1) Up (select)  
 2) ENTER (push)  
 3) Down (select)
