## ARTICLES CONTAINED IN THIS ISSUE

CODE	ARTICLE.....	PAGE
(00)	September STIS New Releases	7
(01)	QMR of the Month .....	1
(01)	QMR of the Month Award Presentation .....	2
(01)	Remanufactured Transmission Replacements.....	2
(01)	2015 Technician ASCENT Program - Important Enhancements .....	7
(02)	Cam Sprocket Replacement for P000A – P000D: A REMINDER .....	3
(15)	2015MY Legacy & Outback, GPS Signal Loss w/ Fujitsu Ten (F10) Navigation System.....	4

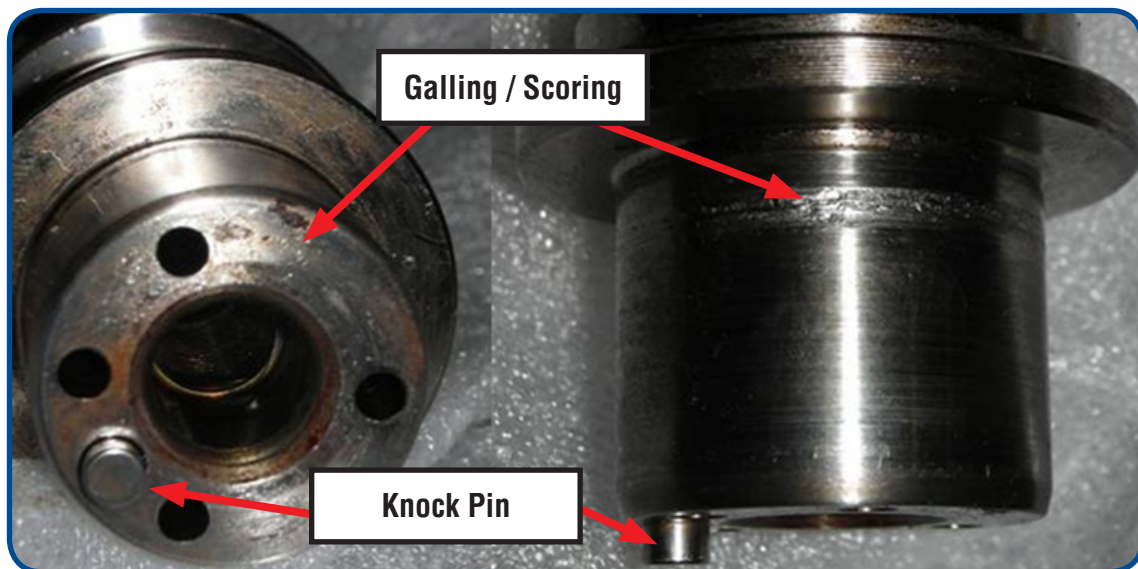
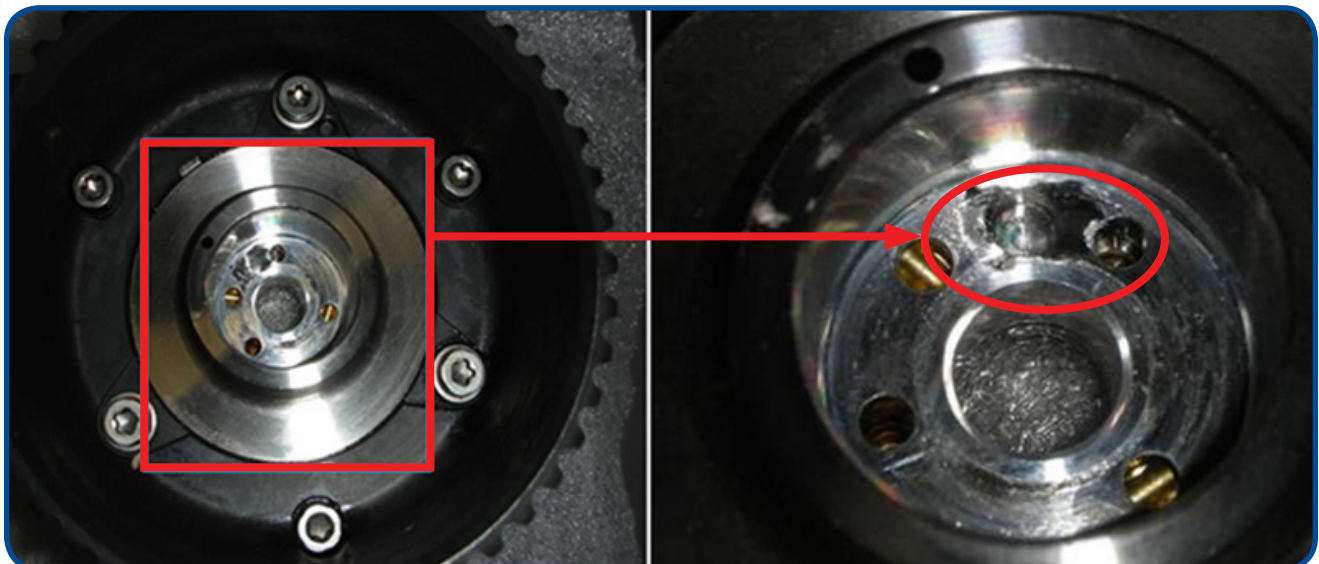
When diagnosis of DTCs P000A - P000D leads to cam sprocket replacement, it is **IMPERATIVE** the alignment dowel (a.k.a. knock pin) located in the front face of the camshaft gets properly aligned with the receiving (knock) hole on the back surface of the new sprocket. The photos show what kind of camshaft and sprocket damage can happen after the retaining bolts are torqued without the pin being installed into the hole of the sprocket properly. Not shown is metal contamination which can also result and cause other engine problems.

**REMINDER:** Always **TAKE YOUR TIME** and make 100% sure:

- The camshaft knock pin and corresponding hole in the sprocket are properly aligned
- The camshaft sprocket is fully seated against the face of the camshaft

**BEFORE** torquing the 3 retaining bolts to 18 Nm (13.3 ft. lbs.).

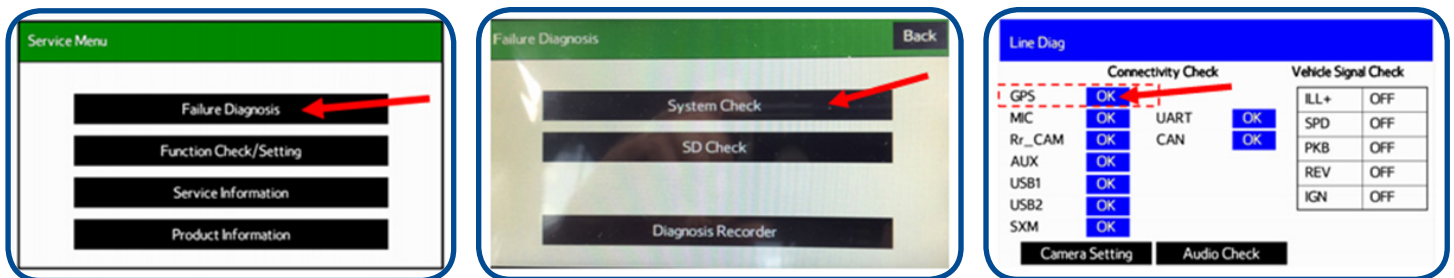
To check the GPS Connectivity, with the Ignition on, enter Diagnostic Mode by pressing and holding the HOME button then pressing the Tune / Track button 5 times. From the Service Menu screen, press Failure Diagnosis, then System Check. The Connectivity Check will be displayed on the following screen.

4. If "OK", replace GPS Antenna Assembly and perform Steps 1-3 again. If GPS Antenna Assembly has already been replaced proceed to Step 5.
5. If Steps 1-3 results are the same and condition can still be duplicated, interview the customer to complete the Questionnaire on the next page then scan and submit the completed form to the Techline for further instructions.
6. If Step 1 result is now **YES**, the repair is complete. **STOP**. If the condition can not be duplicated proceed to Step 5.
7. If Step 2 result is now **YES**, remove the aftermarket device and repeat Steps 1-3.
8. If Step 3 result is now **NO**, check for poor contact / connection between GPS antenna and the head unit then repeat Steps 1-3.
