SERVICE BULLETIN

APPLICABILITY: 2012-15MY Impreza 2.0L Models
2013-15MY XV Crosstrek Models

NUMBER: 12-194-15
DATE: 11/11/15

SUBJECT: Eliminating Gap between Headlamp and Bumper Cover

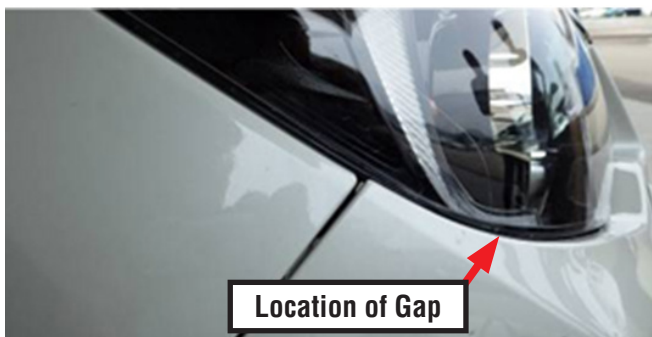
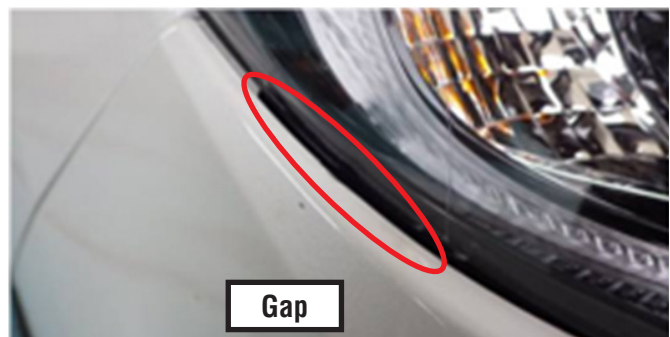
This bulletin announces a design change to the front bumper corner mounting bracket to address concerns of a gap between the top edge of the cover and the headlamp assembly as shown below.
