SERVICE BULLETIN

APPLICABILITY: 2013-14MY Legacy and Outback Models with 2.5L FB Engines
 2011-14MY Forester Models with 2.5L FB Engines
 2015 MY Forester (Manual Transmissions Only) with 2.5L FB Engines
 2012-13 MY Impreza and XV Crosstrek Models with 2.0 FB Engines
 2014-15 MY Impreza and XV Crosstrek Models (Manual Transmissions Only) with 2.0 FB Engines

NUMBER: 02-157-14R
DATE: 08/28/14
REVISED: 11/19/15

SUBJECT: Surface Treatment Change To Oil Control Piston Rings

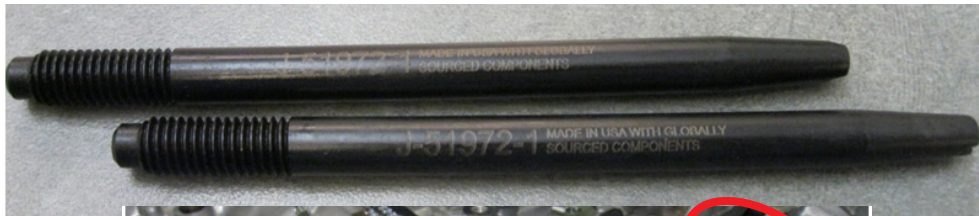
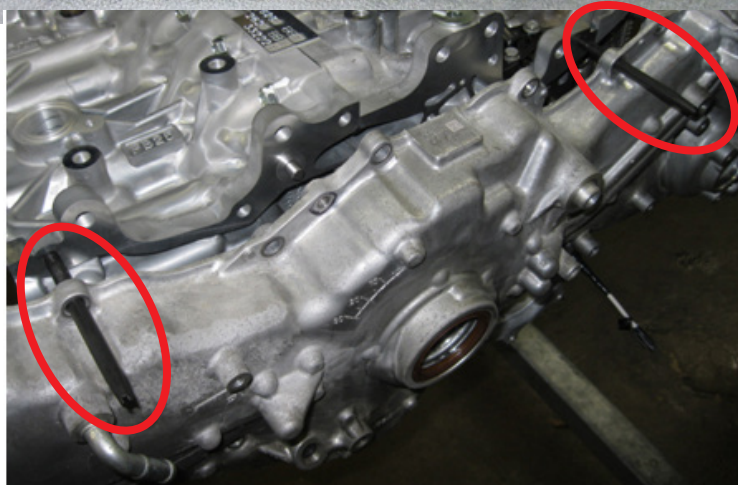
- If alignment pins are not used and the sealer gets disturbed during the cover installation, unless properly addressed, the affected area(s) will most likely be the source of an oil leak after reassembly. Don't hesitate to use a helper for the cover installation to prevent this from happening.

- **IMPORTANT:** When re-installing the front cover assembly, be very careful to not allow it to contact any of the timing sprockets. If contact does occur, it will most likely be with the exhaust sprockets and it is almost a guarantee the fresh silicone sealer beads applied to the cover will be disturbed. To minimize the possibility of this happening, alignment pins as shown in the photos below have been developed to “guide” the cover into its proper position without disturbing the fresh sealer. The Subaru Special Tool number for the alignment pin kit is J-51972. Each kit includes 2 pins.
