QUALITY DRIVEN® SERVICE

## REPAIR PROCEDURE

**NUMBER:** WQV-57

**SUBJECT:** Repair Procedure for Subaru Recall  
Campaign Stop Sale WQV-57 Propeller  
Shaft Attaching Bolt Torque

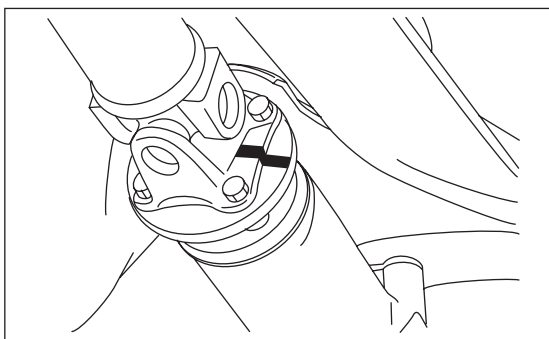
- If all 4 nuts, bolts and washers require replacement, always confirm the paint marks of the flange and yoke (A) are aligned as shown in the illustration below before reinstalling the new hardware.

- Once it has been confirmed the bolts / nuts are not loose or any bolts / nuts found to be loose have been replaced (including a new washer), torque the 4 flange nuts to the specified value in the Service Manual: 31Nm (22.9 ft. lbs.) to complete the procedure.

### TIGHTENING TORQUE

31 N.m (3.2 kfg-m, 22.9 ft-lb)

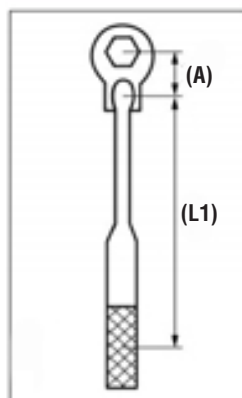
- Due to the location of the nuts, extra care must be used to avoid damage to the dust cover on the differential seal due to contact with tightening tool. If the dust cover is deformed or damaged, differential replacement may be required as this cover is not serviceable. To avoid this condition, SOA recommends the use of an appropriate torque extension tool along with a standard torque wrench. When using a torque extension, be sure to adjust the torque value appropriately to compensate for the length of the extension used. A formula is provided below.

$$T = L1 / (A + L1) \times T1$$

T = New Torque Specification

L1= Length of the torque wrench from the center of the handle to the center of the socket mount.

A = Length of the adapter from the middle of the socket mount to the middle of the wrench.

T1=Original torque specification
