SERVICE BULLETIN

APPLICABILITY: 2015-16MY Legacy and Outback Models
SUBJECT: Design Change to the Fuel Filler Door Assembly

NUMBER: 09-61-15R
DATE: 11/24/15
REVISED: 12/01/15

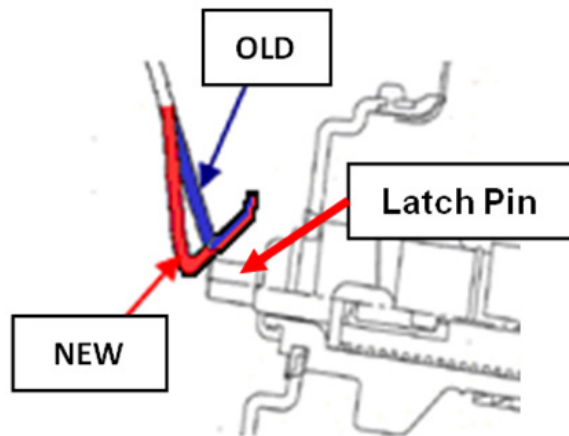
This bulletin announces a design change to the fuel filler door (saucer) assembly to address customer concerns of it being difficult to open and / or close. The striker portion's shape has been changed as shown in the cross-section illustration below along with the type of plastic material used in the construction of the saucer assembly.

If a complaint of the fuel filler door being hard to open or close is confirmed, replace the saucer assembly using the applicable parts listed above following the procedure in the applicable Service Manual.

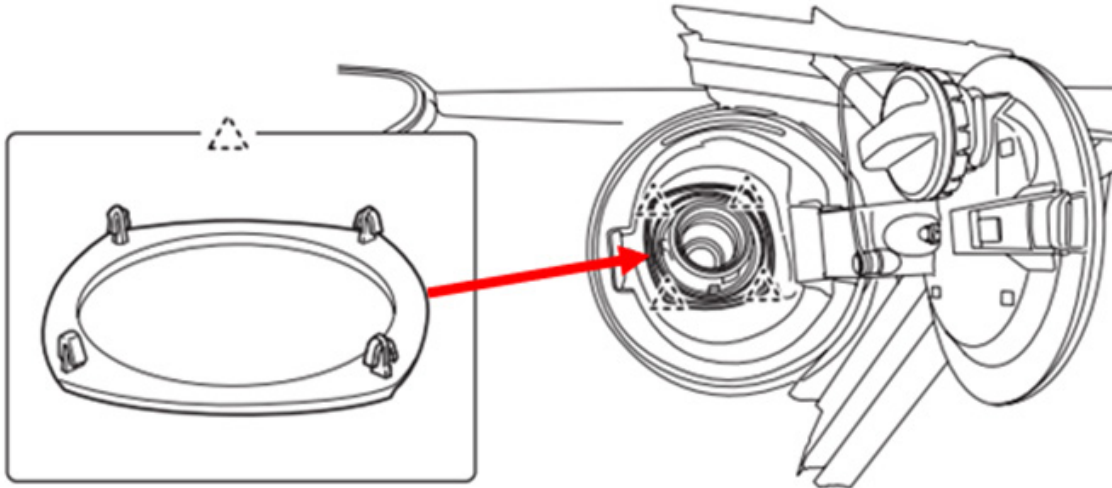
NOTE: The new plastic lock ring (seal) shown below **must** be replaced also as it is a one-time use part.

- **NEVER** attempt to re-use a previously installed part.
- **ALWAYS** take precautions to protect the vehicle finish when removing / installing the assembly.
