## SERVICE BULLETIN

**APPLICABILITY:** 2011-2014MY Forester Models with FB Engine

**NUMBER:** 02-131-12R

**SUBJECT:** Oil Seepage Diagnosis and Repair Procedures

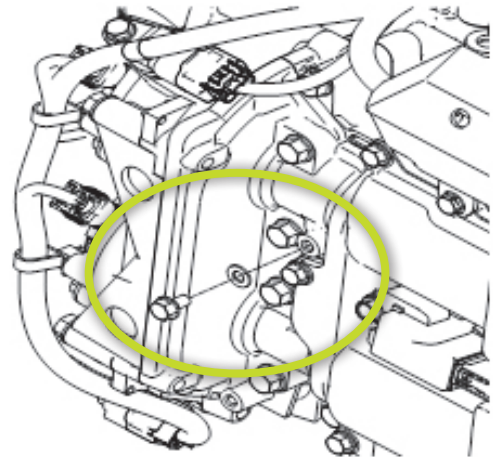
If oil seepage is verified coming from the 6mm threaded hole in the left-hand camshaft cap, install the specified bolt and flat washer.

**Bolt:** Part# 800206180

**Washer:** Part# 031106000

**Tightening Torque:** 6.4 +/- 0.5 Nm  
 (57 +/- 4 inch-pounds)

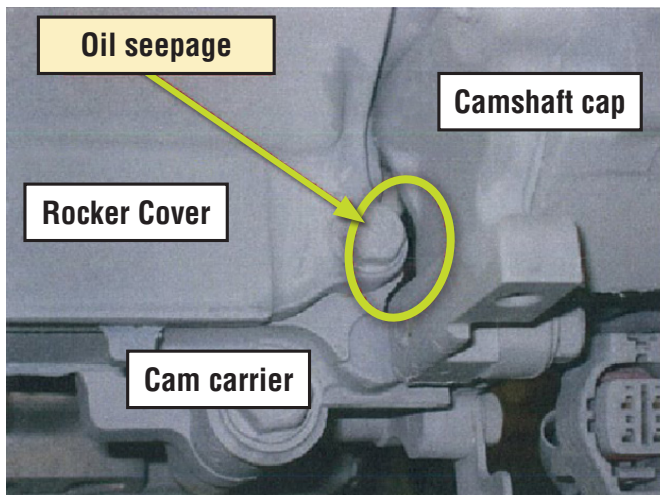
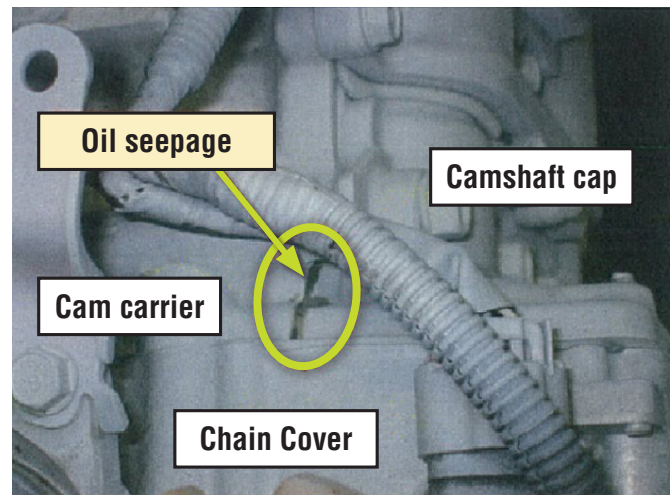
If oil seepage is verified coming from the front camshaft cap or cam carrier as shown in the photos below, remove the cam cap and clean both surfaces thoroughly before applying sealer. **Note:** The 2 o-rings between the camshaft cap and the cam carrier will need to be replaced as they are not re-usable.

Apply Liquid Gasket, ThreeBond 1280B, (Part No. SOA5499100) or equivalent\* as shown below:

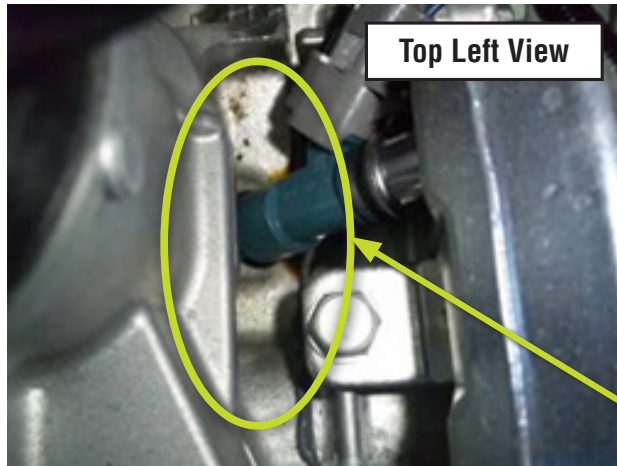
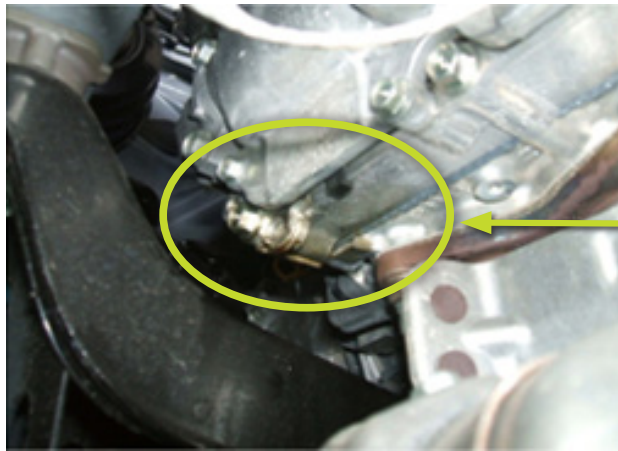
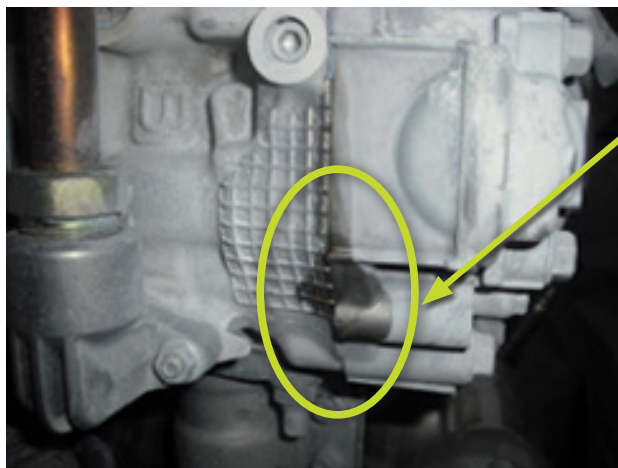
If oil seepage is verified coming from between the cam carrier and the cylinder head as shown in the photos below, remove the cam carrier. Clean the machined sealing surfaces thoroughly and then re-seal using Liquid Gasket ThreeBond 1280B, (Part No. SOA5499100) or equivalent\*. As shown in the photos below, the o-rings between the cam carrier and the cylinder head will need to be replaced as they are not re-usable. This would also be a good time to clean the Active Valve Control System (AVCS) filter screens which are contained in the cam carriers. **NOTE:** The filter screens are one-time use and must be replaced if they need to be removed. The replacement filter part# is 14451AA050.

Cam carrier seepage seen from top left and lower right side of engine

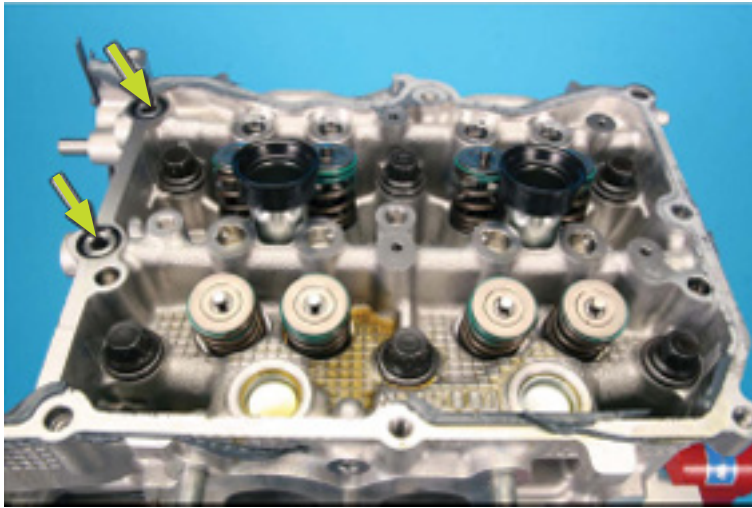
**Cam carrier o-rings requiring replacement**

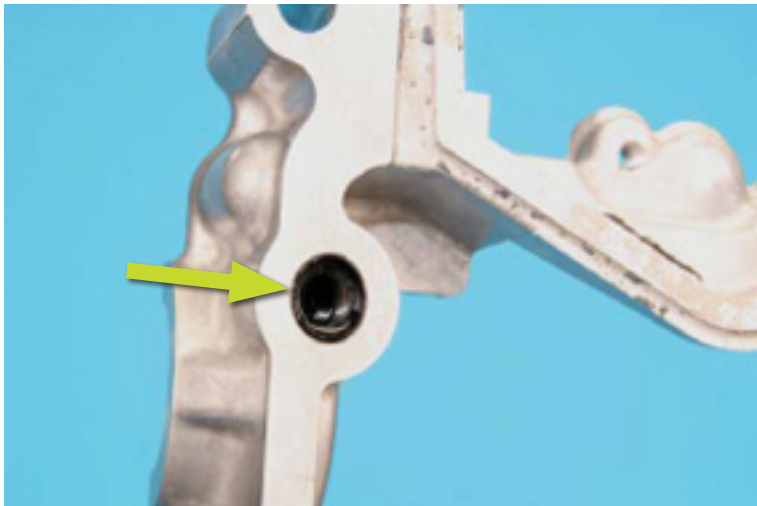
**AVCS filter screen in cam carrier**

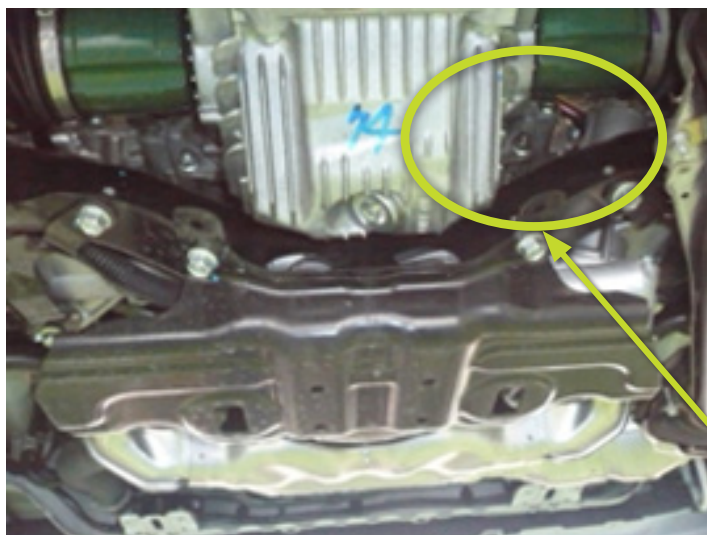
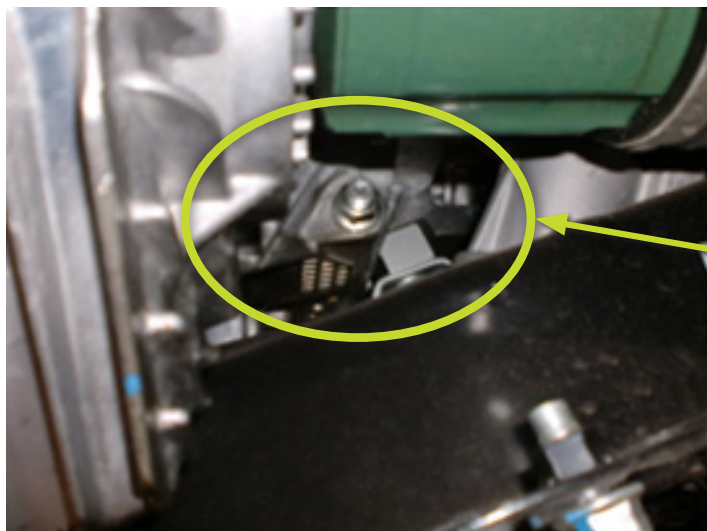
**As viewed from the rear, oil seepage from the upper pan to engine block sealing area may be present in these areas.**

If you find engine oil seepage between the cylinder block and upper oil pan, remove the upper oil pan, clean the machined sealing surfaces thoroughly and then re-seal using Liquid Gasket ThreeBond 1280B, (Part No. SOA5499100) or equivalent\*. **Note:** The o-rings between the upper oil pan and the cylinder block along with those between the upper and lower oil pan will need to be replaced as they are not re-usable.

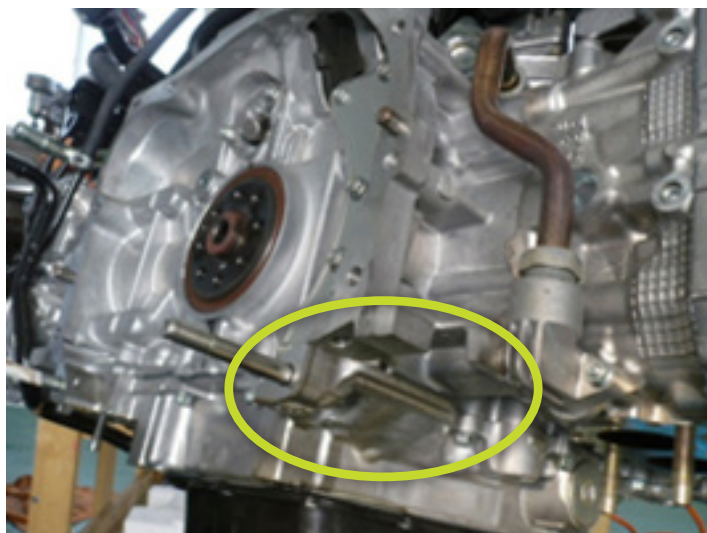
Photo shows seepage from upper oil pan to engine block sealing surfaces.

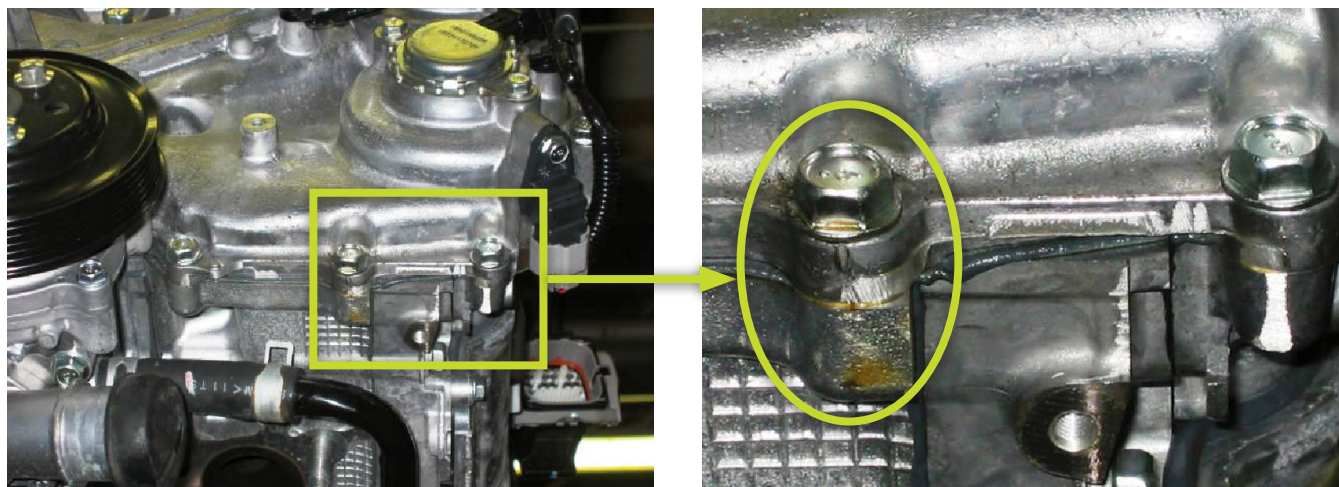
**Note:** Only reseal the front chain cover AFTER confirming there is no oil seepage coming from the cam retainer cap (area 1) as previously described.

1. If there are no oil droplets found on the engine under-cover or the lower radiator hose, thoroughly clean the chain cover sealing area along with the surrounding cylinder head and crankcase areas. Re-check for oil seepage again at the next service interval.
2. If the front chain cover is leaking and needs to be resealed, follow the repair procedure in the applicable Service Manual. Thoroughly clean and inspect the sealing surfaces then re-seal using Liquid Gasket ThreeBond 1280B, (Part No. SOA5499100) or equivalent\*.
