SERVICE BULLETIN

APPLICABILITY: 2013-14MY Legacy and Outback Models with 2.5L FB Engines
 2011-14MY Forester Models with 2.5L FB Engines
 2015 MY Forester (Manual Transmissions Only) with 2.5L FB Engines
 2012-13 MY Impreza and XV Crosstrek Models with 2.0 FB Engines
 2014-15 MY Impreza and XV Crosstrek Models (Manual Transmissions Only) with 2.0 FB Engines

NUMBER: 02-157-14R
DATE: 08/28/14
REVISED: 12/07/15

SUBJECT: Surface Treatment Change To Oil Control Piston Rings

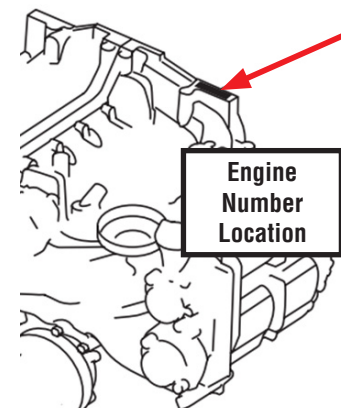
*** NOTE:** When determining the engine number, use the **LAST 8** characters of the number stamped into the boss on top of the block adjacent to the starter and shown in the illustration. The engine number range for the FA1 assembly line is 800000 to 930025 and the FB2 range is 000000 to 652640.
