TECHNICAL BULLETIN  
JTBO0377NAS1  
05 JAN 2015

Fluid Ingress Into Central Junction Box

**XF (X250)**

**Model Year:** 2012-2015  
**VIN:** S20753-U50461

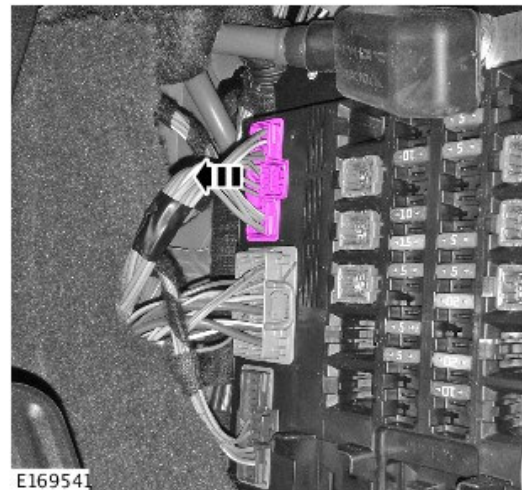
Disconnect the Central Junction Box (CJB) connector (C3BP01E) and inspect the connector for moisture and/or corrosion.

- If there is no corrosion and/or moisture, **NO** further action required.
- If corrosion and/or moisture is found, continue to the next step.

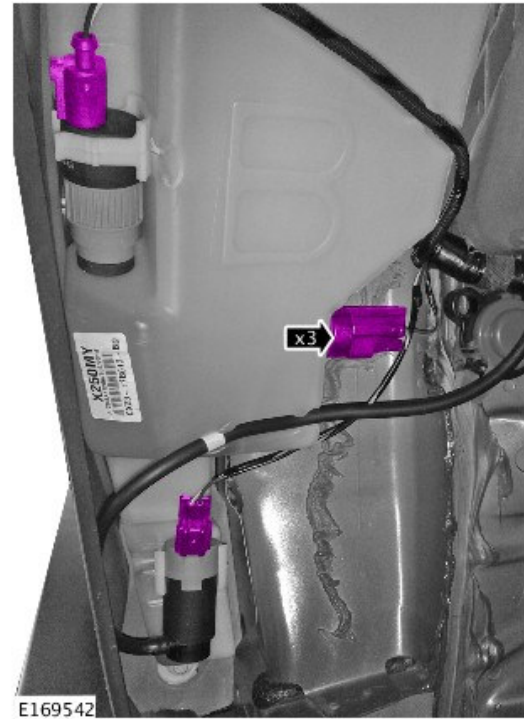
4. Remove the front right-hand fender splash shield, (see TOPIx Workshop Manual, section 501-02).
5. Disconnect all three electrical connectors and inspect for moisture.
