TECHNICAL BULLETIN
JTB00388NAS1
05 JAN 2015

SECTION: 211-02

Hydraulic Power Steering System Diagnosis

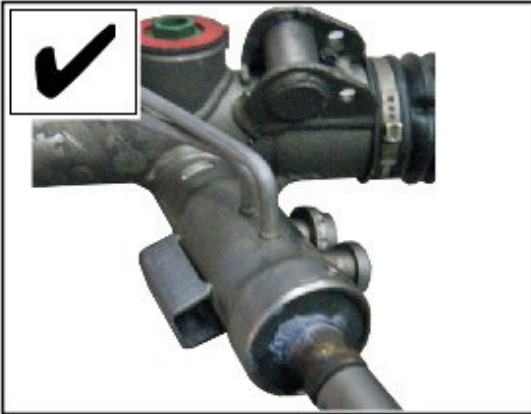
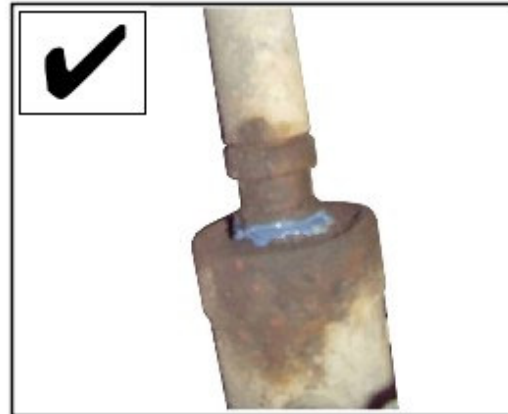
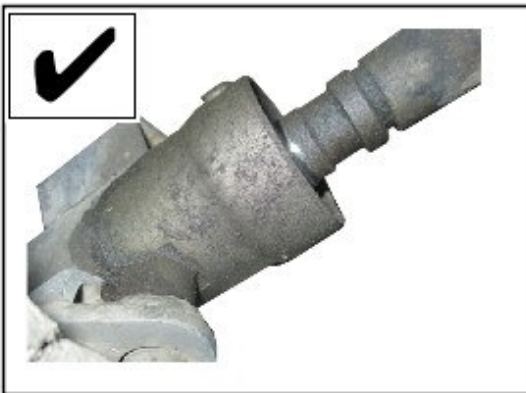
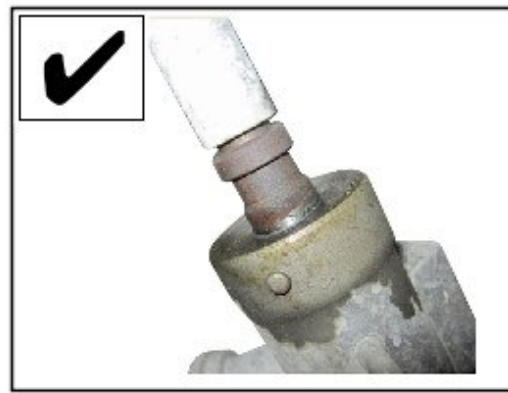
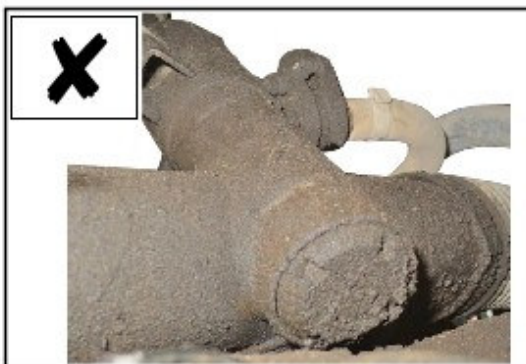
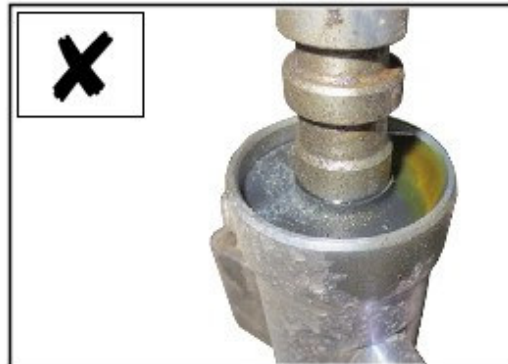
E170144

- NOTE:** misting / dampness around the input shaft seal can be mis-diagnosed as leaks (see top four pictures with '✓'); this is normal. Suspected leaks ('X') should always be verified by cleaning and chalking.

Fluid Misting / Dampness Around Pinions and Bellows

- 'Misting' or a damp area may be commonly seen around the steering gear pinion tower seal and the steering gear bellows. This is normal and occurs on most hydraulic dynamic seals due to their design and is not a reason to change the steering gear, nor does it indicate the part will fail early or later in life. If there is a suspicion of a leak, then normal procedures using cleaning and chalk should be employed.
