TECHNICAL BULLETIN
K225NAS2
14 JAN 2015

SECTION: 303-12F

Service Action: Charge Air Radiator Duct Bolt Torque Relaxation

XF (X250)

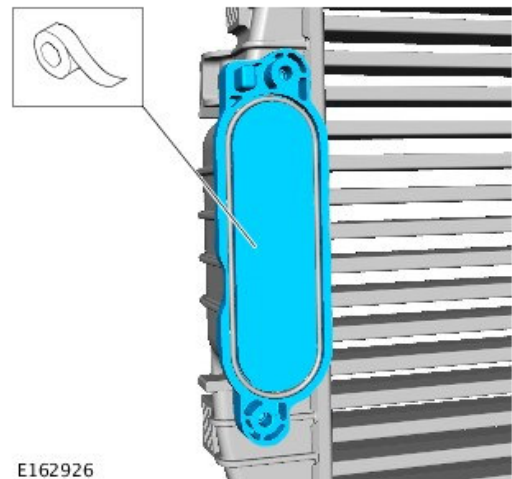
2. Tape over the charge air radiator left-hand end tank opening to prevent any debris from entering the charge air radiator.

- Repeat to the charge air radiator right-hand end tank opening.

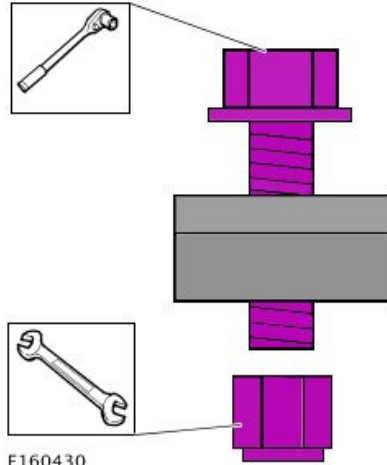
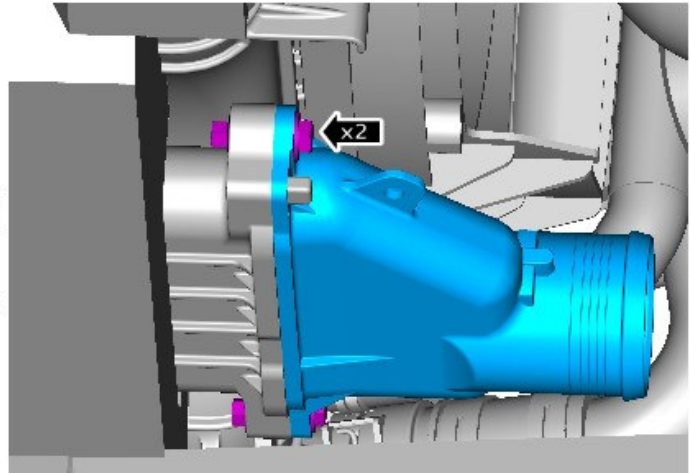
**NOTE:** make sure the rubber sealing gasket between the duct and the charge air radiator is correctly positioned.

Assemble the

duct to the charge air radiator left-hand end tank opening:

- Use the 2 bolts (C2D4727) and the 2 lock nuts (C2P2765) and a suitable 10mm spanner to hold the lock nut
- Torque: $7\text{Nm} \pm 1.1\text{Nm}$.

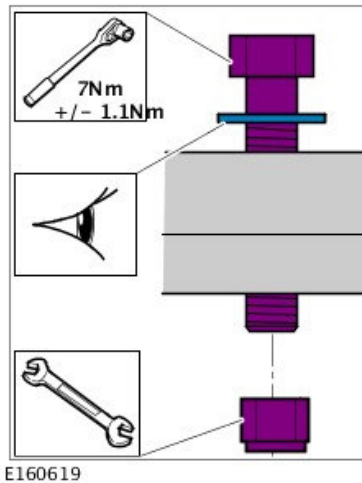
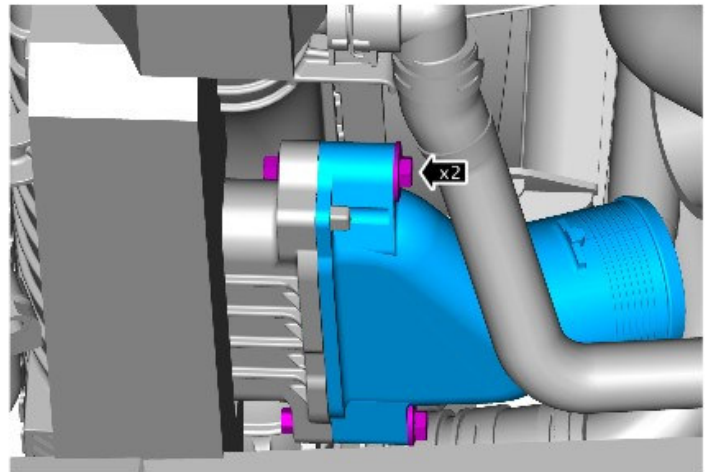
**NOTE:** make sure the rubber sealing gasket between the duct and the charge air radiator is correctly positioned.

**NOTE:** make sure the washer is next to the bolt head to prevent any damage to the plastic charge air radiator end tank during the tightening process.

Assemble the duct to the charge air radiator right-hand end tank opening:

- Use the 2 bolts (C2D2734), 2 washers (C2P23515), and 2 lock nuts (C2P2765) and a suitable 10mm spanner to hold the lock nut.
- Torque: $7\text{Nm} \pm 1.1\text{Nm}$.
