Special Service Message

SSM 72172 - Rear Vanity Mirror XJ

Models : X351 - XJ

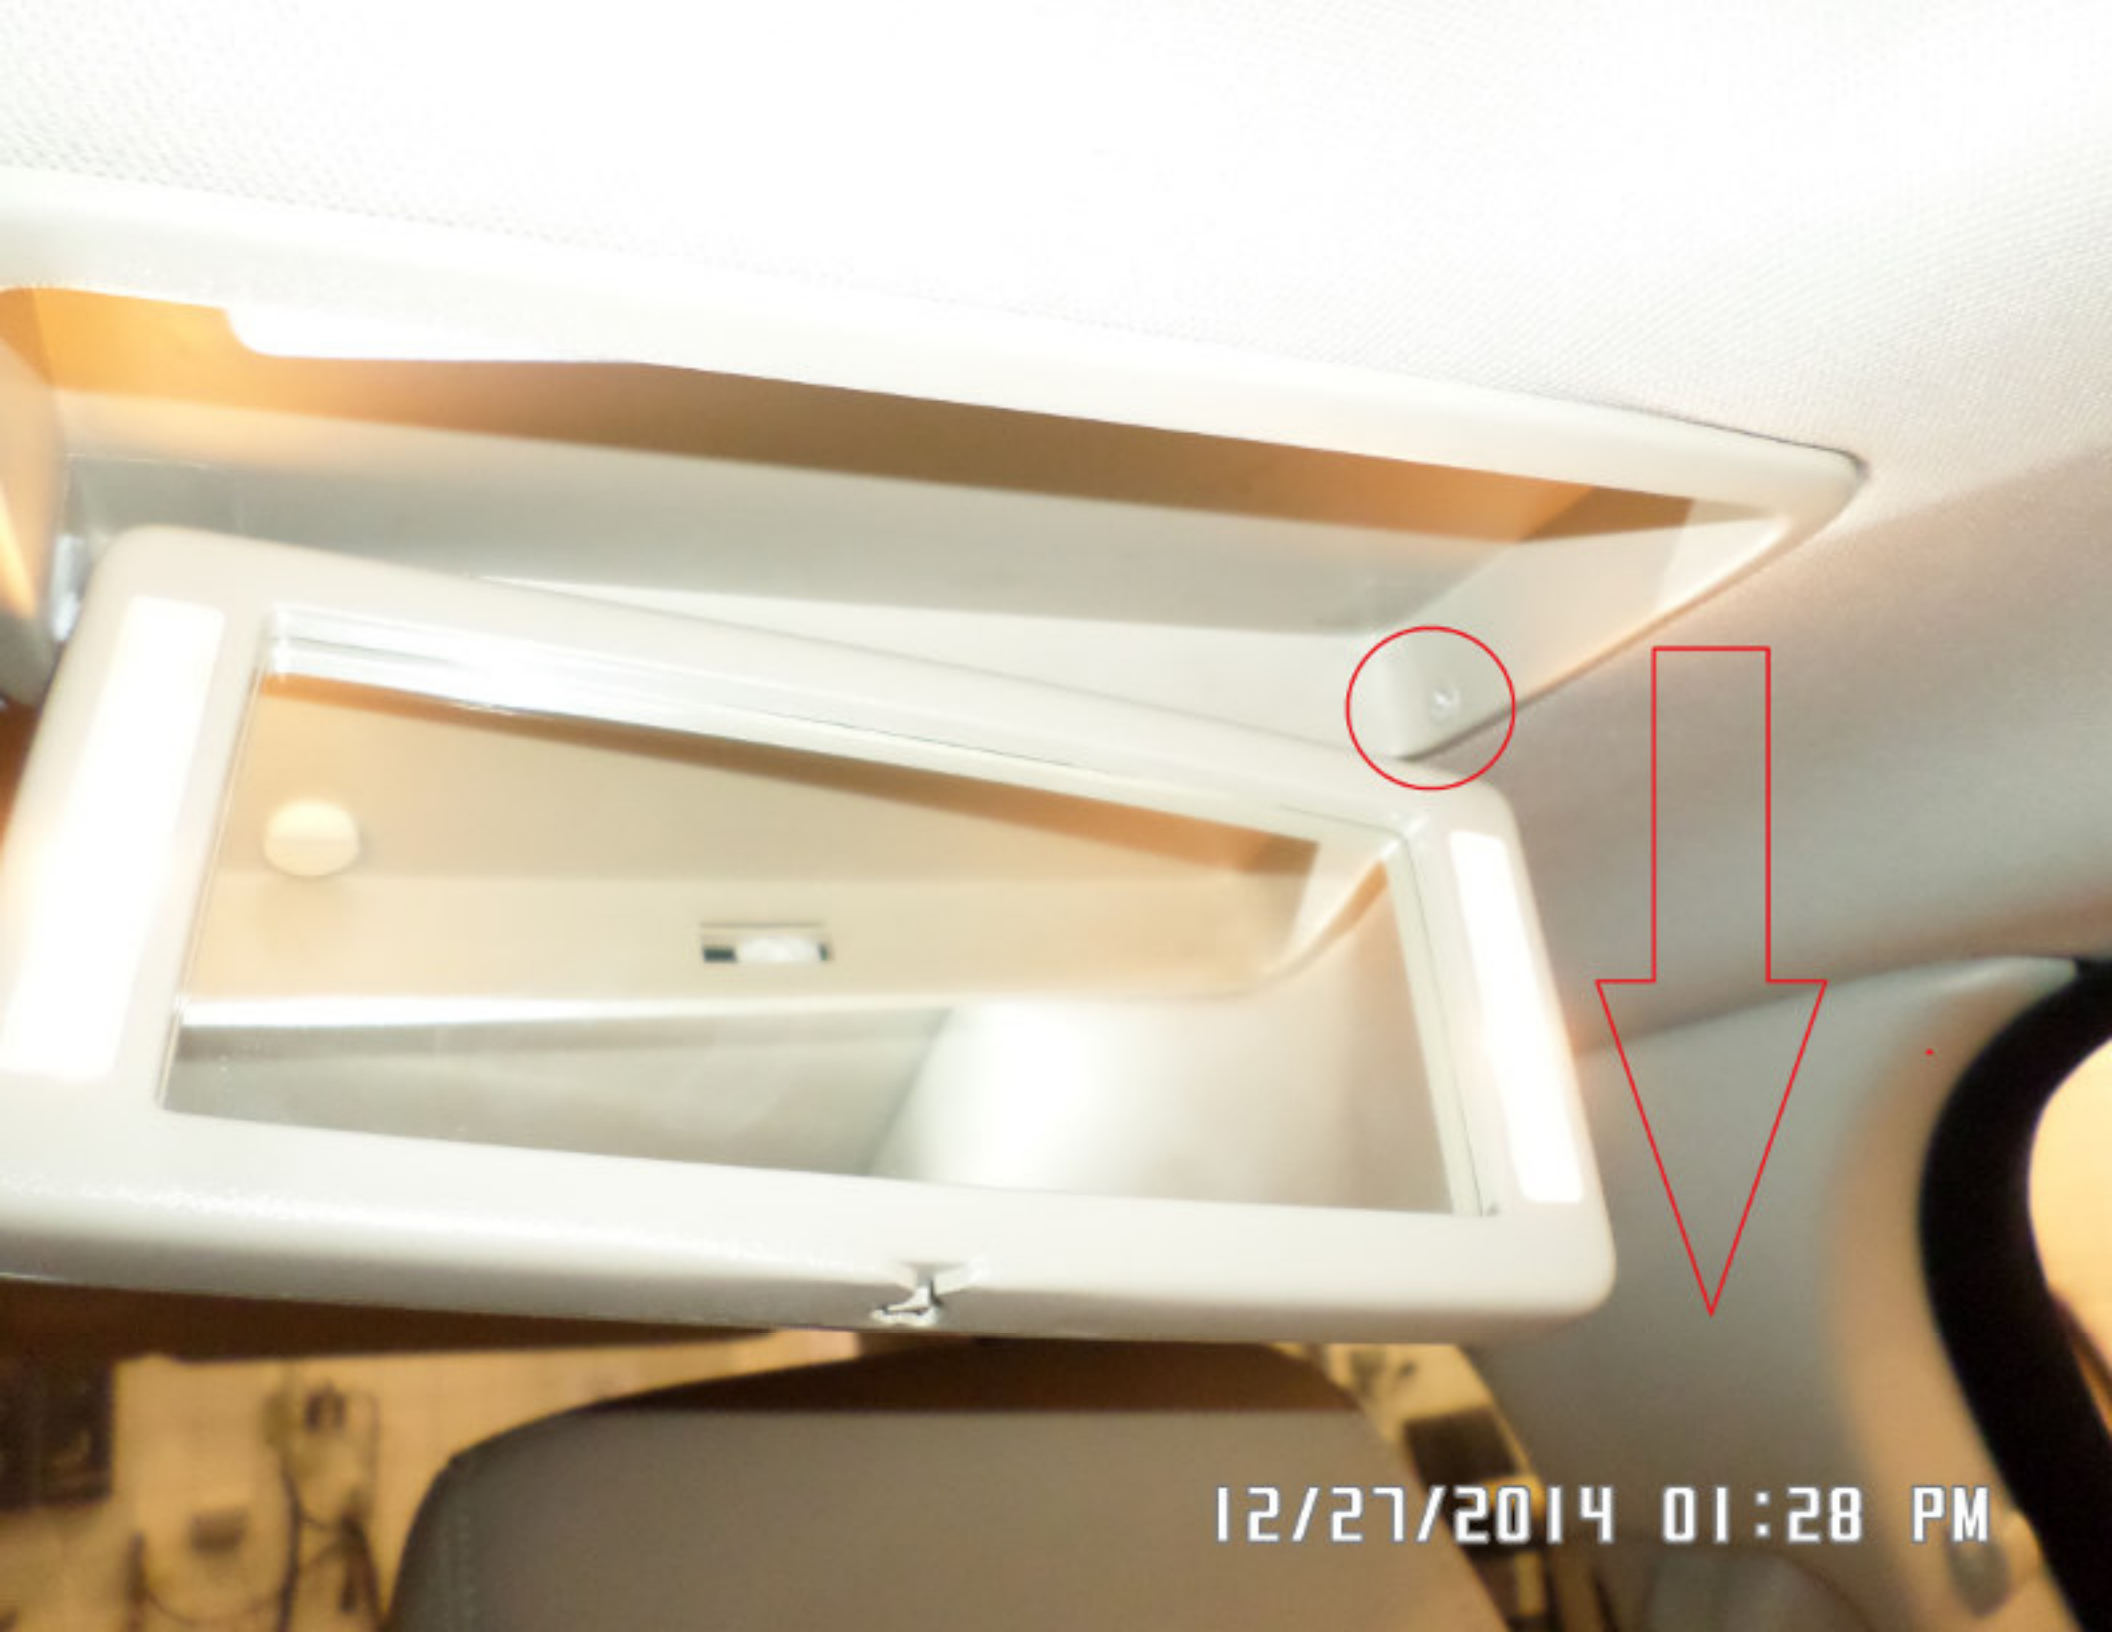
File : [vanity mirror XJ.\[1\].JPG](#)

Rear Vanity mirror, when opened may become dislodged or hang down.(see attached picture)

Incorrect process during manufacture causing swivel pin to fracture and eventually fail.

Manufacturing process revised from VIN V72560.
Current service replacement parts are to the revised condition
