TECHNICAL BULLETIN

K278 UPS3815-2bNAS1

Update Prior to Sale: Mass Damper Fixing Bolt Torque

XF (X250)

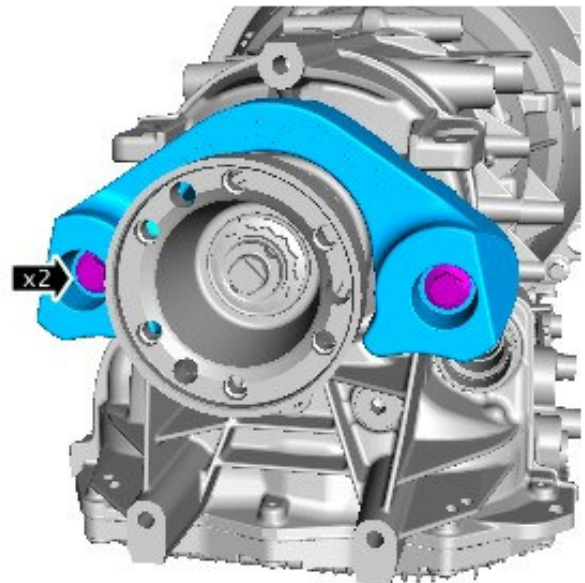
E178086

Situation: A potential issue has been identified on a limited number of 2015 model year XF (X250; 3.0L SC V6 only) vehicles where the bolts used to retain the transmission mass damper may have been tightened to an incorrect torque value.

**NOTE: transmission shown removed for clarity.**

Tighten the two (2) transmission mass damper retaining bolts.

- Torque: 63 Nm \pm 8 Nm
