TECHNICAL BULLETIN
JTB00293NAS2
08 APR 2015

Incorrectly Wired Auxiliary Input Jack

XJ Range (X351)

Model Year: 2013-2014

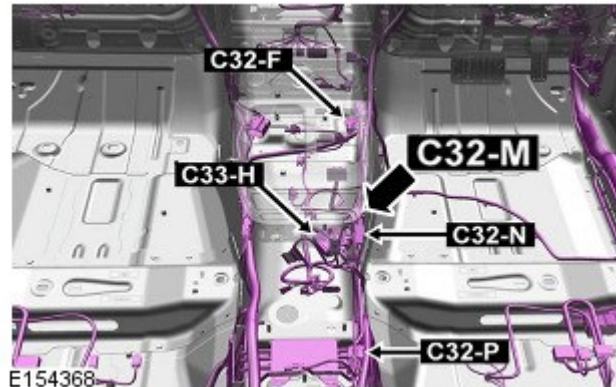
2.

Access connector C32-M (connection between user interface panel and Aux).

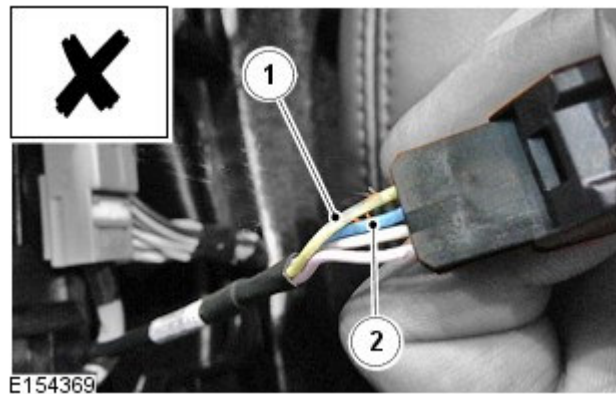
**NOTE: In-vehicle condition – INCORRECT (Blue [BU] in cavity 3; Yellow [YE] in cavity 4).**

Using suitable pin out tool, change the pin location of the Blue (BU) and Yellow (YE) wires:

1. Yellow wire (YE) to cavity 3.
2. Blue wire (BU) to cavity 4.

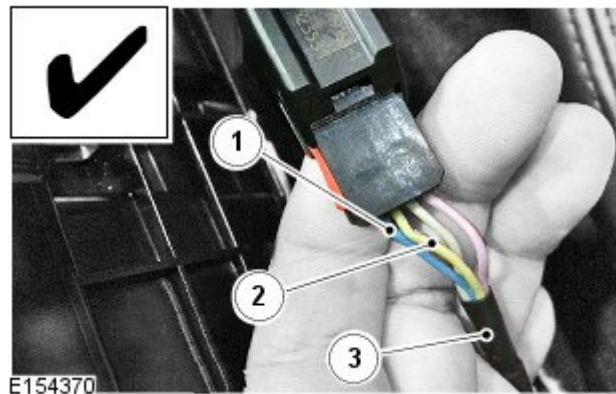
4. Harness with wires in the correct condition.

1. Blue wire (BU) in cavity 4.
2. Yellow wire (YE) in cavity 3.
3. Connector C32-M harness.
