TOPIx - SSM72219 - F TYPE 16 MY SD Card fails to initialise

Reference	SSM72219
Models	F-TYPE / X152
Title	F TYPE 16 MY SD Card fails to initialise
Category	Electrical
Last modified	02-Apr-2015 00:00:00
Symptom	204000 Instrumentation
Attachments	SD Card Inspection.pdf
Content	Issue: SD card fails to initialise

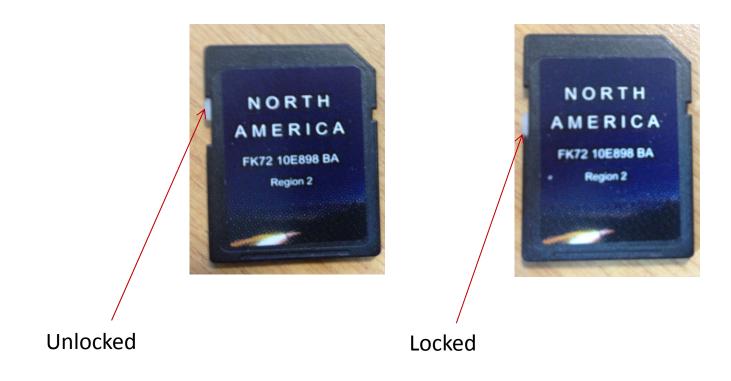
SD Card Visual Inspection

Cause: This issue may be caused by the SD micro switch being in the wrong position (i.e. Locked) When the SD card is in locked position the head unit may not detect the card.

Action: Check the SD switch position is always in the unlocked position as per the attachment.

If the SD card is found with the switch in the wrong position, correct the switch position and reinsert into SD card slot and carry out the following process.
