Reference	SSM72238
Models	XF / X250
Title	XF Saloon (X250) Partial Delamination of Rear Door Finisher
Category	Body
Last modified	22-Apr-2015 00:00:00
Symptom	108000 Ext. Trim/Accessories
Attachments	Example.pdf

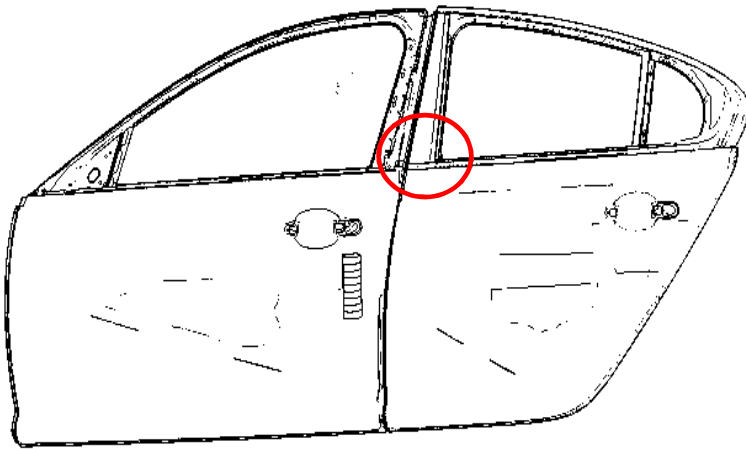
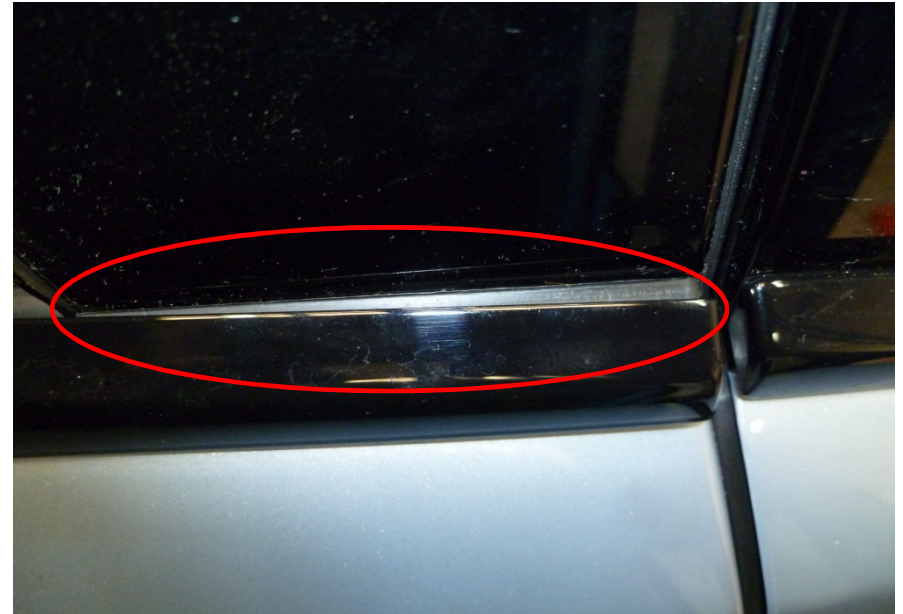
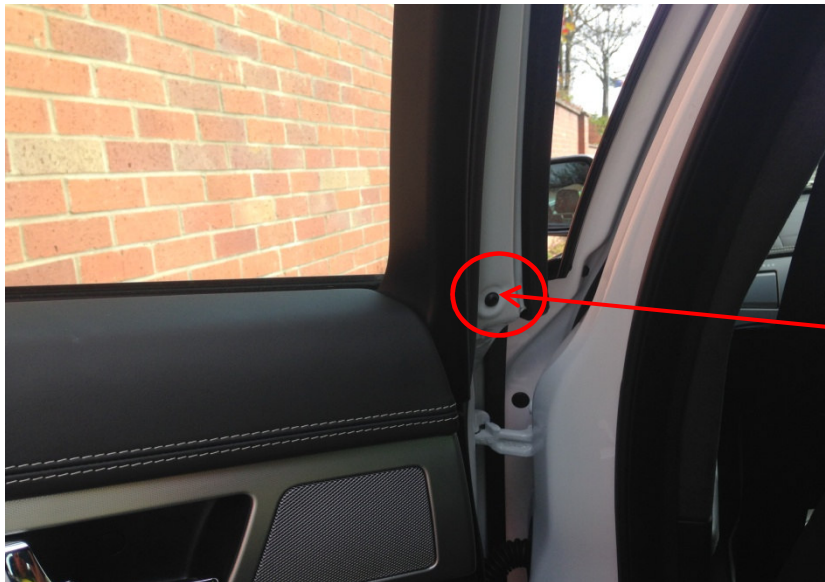
Example

Customers have reported that chrome and black door finishers on the rear door become slightly adrift due to partial delamination at the base of the rear door 'B' post. (Please view attachment example)

Excess applied torque during profiling can cause the fixing screw to protrude through the moulding into the adhesive strip. Over time, this can weaken the adhesive creating the partial delamination.

1. Replace rear door bright work finisher
2. Remove and discard the existing fixing screw and replace with **C2Z31690**
3. Torque fixing to 2.1Nm
