TECHNICAL BULLETIN  
JTB00421NAS1  
19 MAY 2015

**SECTION: 501-00**

C Pillar Paint Chafe

**XF (X250)**

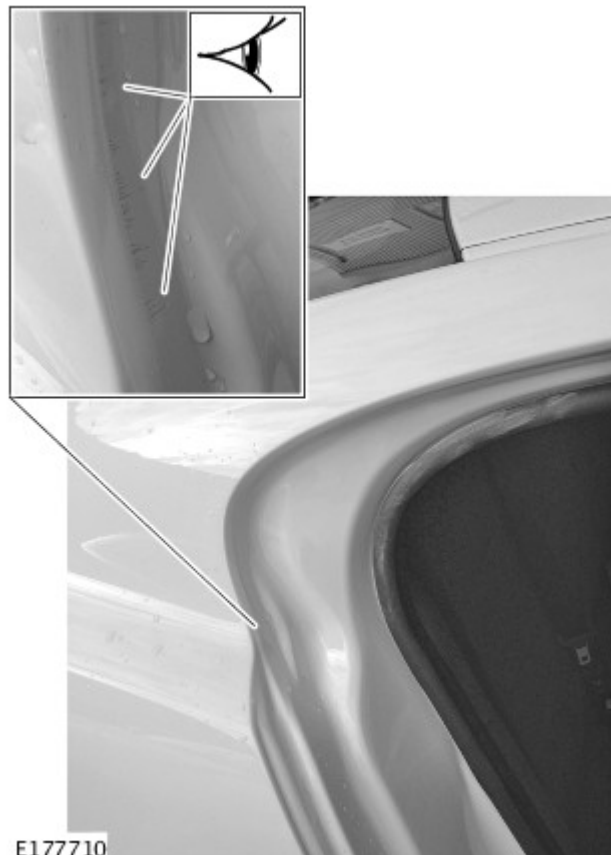
1.

**Situation:** Paint scratches between the rear door and rear door aperture may be evident.

Check for damage to the paintwork in the rear door aperture.

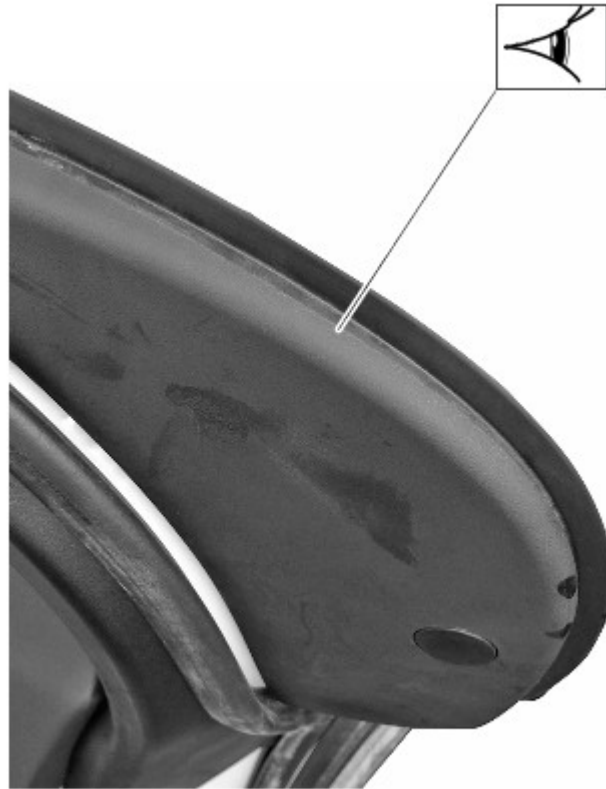
E177711

Check for damage to the rear door frame upper finisher.

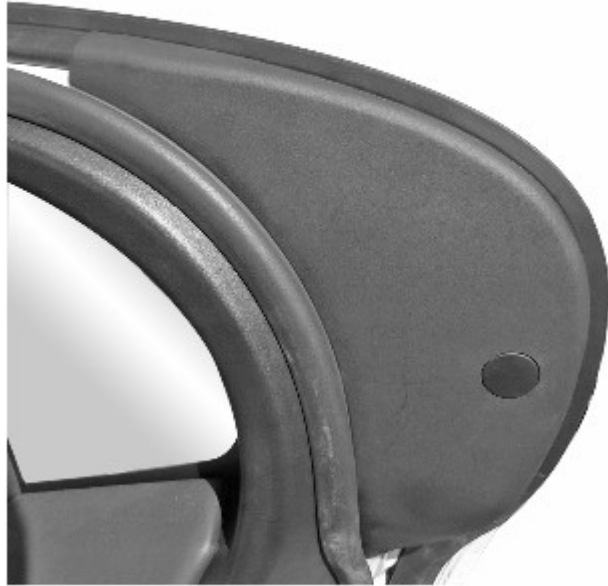
E177761

Check the rear door frame upper finisher is correctly located into the rear door aperture.

If the rear door frame upper finisher does not locate correctly, replace the rear door frame upper finisher (see TOPIx Workshop Manual, section 501-11; **follow Steps 5 and 6 only of the TOPIx procedure**).

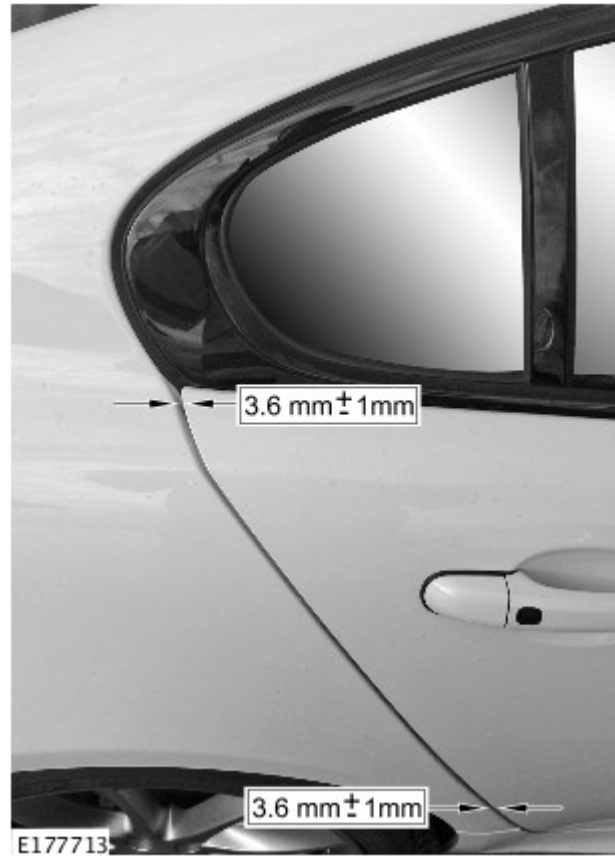
5.

**Cause:** This may be caused by a combination of door trim installation and rear door alignment.

Check the rear door to rear quarter panel gap is correct (see TOPIx Workshop Manual, section 501-26, for correct specification and body gap measurements\_.

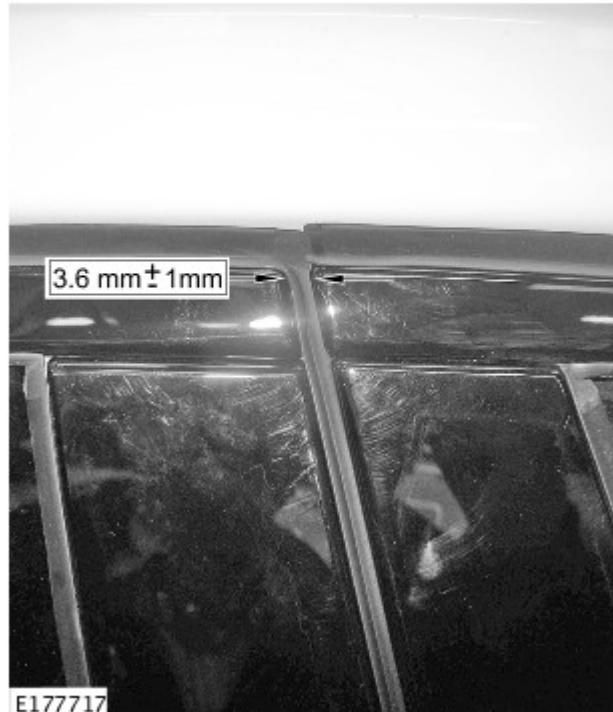
7.

Check for the 'clash' condition between the front and rear door after adjusting the rear door. The correct body gap must be to specification to avoid this condition occurring (see TOPIX Workshop Manual, section 501-26, for correct specification and body gap measurements).

- If the 'clash' condition occurs and the front door to rear door gap is **not** within specification, continue from Step 8.
- If the 'clash' condition does not occur and the front door to rear door gap **is within** specification, continue from Step 12.

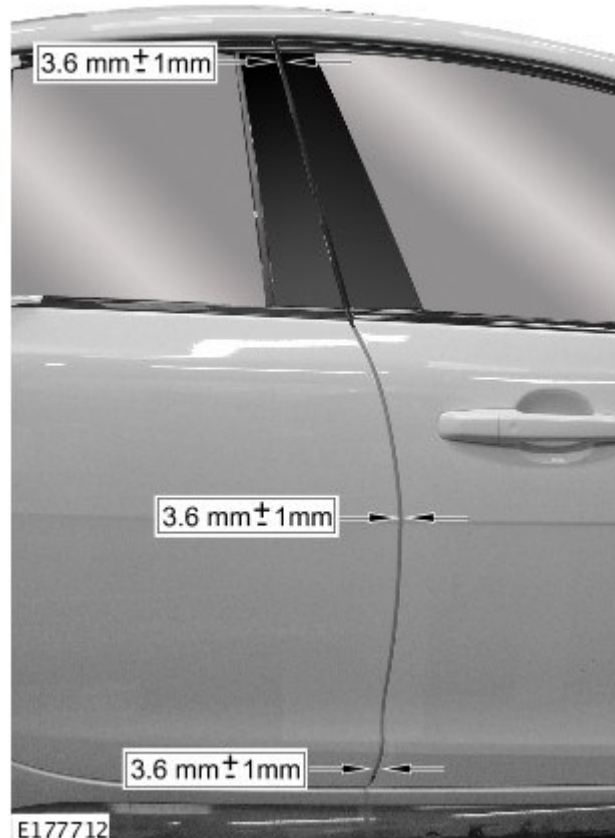
8.

Check the rear door to front door panel gap (see TOPIx Workshop Manual, section 501-26, for correct specification and body gap measurements).

- If the rear door to front door panel gap is **not** within specification, continue from Step 9.
- If the rear door to front door panel gap is **within** specification, continue from Step 12.
