TECHNICAL BULLETIN  
JTB00283NAS2  
21 JUL 2015

Folding Top Glass-to-Top Bonding

**XK Range (X150)**

**Model Year:** 2007-2015  
**VIN:** B00379-B86792  
**Manufacturing Plant:** Castle Bromwich

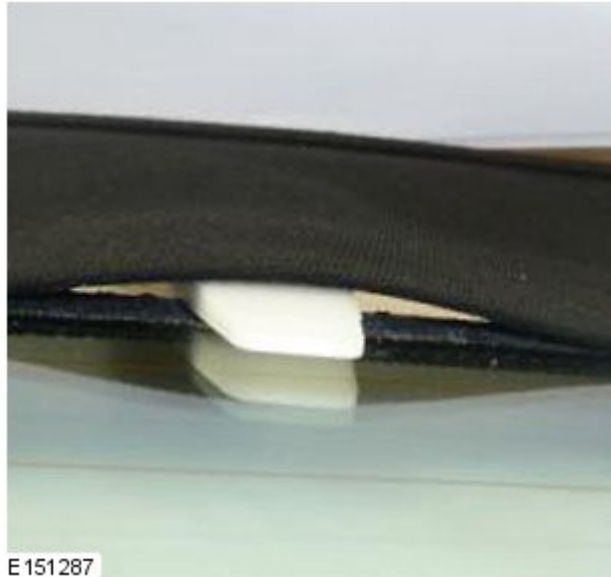
The bonding between the folding top and the rear glass may require repair.

**NOTE:** the maximum length of any one (1) area that can be re-bonded is 350mm (13.75in); up to a maximum of three (3) repairs around the glass are permitted.

Folding top glass-to-top bond.

**Action:** In the event of a customer concern of the above, refer to the Repair Procedure outlined below to re-bond the folding top to the rear glass.
