Intermittent 2nd - 3rd Up Shift Flare

Service Category Drivetrain

Section Automatic Transmission/Transaxle

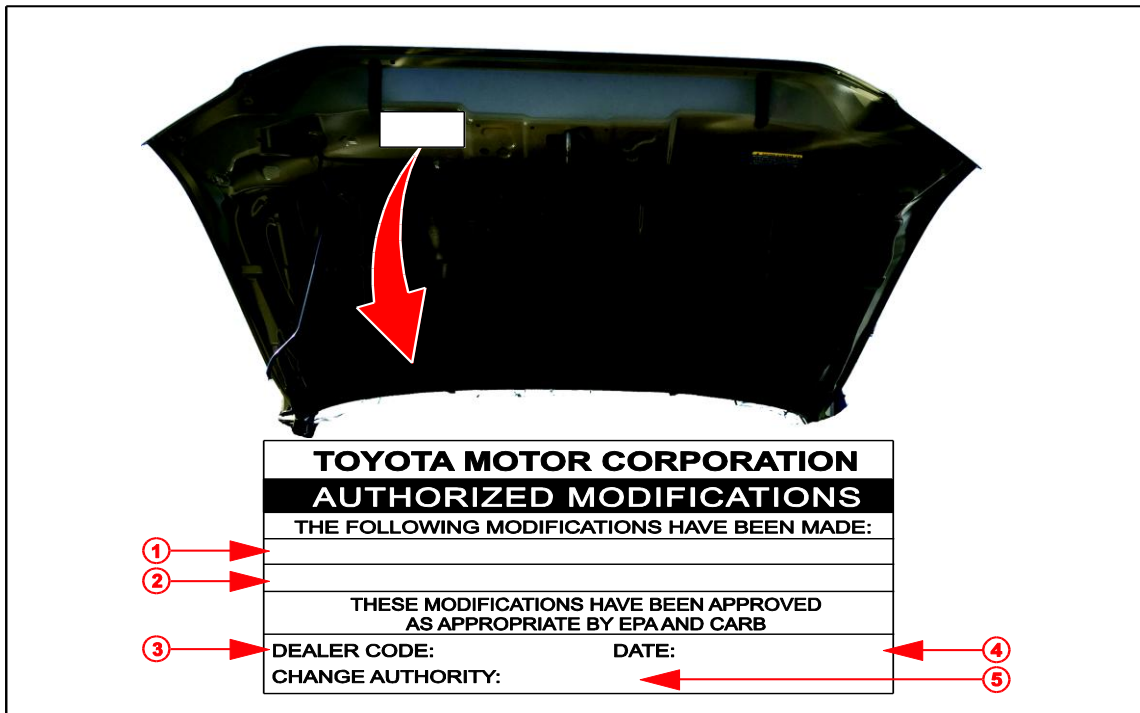
1	Replacement ECM (PCM) Part Number (i.e., 89661-04A34)
2	New Calibration ID(s) (i.e., 30426400)
3	Dealer Code

4	Date Completed
5	This SB Number

- With vehicle at normal operating temperature, test drive and confirm there is a shift flare during 2-3 upshift. Is shift flare present?
 - YES** — Go to step 2.
 - NO** — This bulletin does NOT apply.
- Check for the Authorized Modifications Label affixed to the vehicle in the location shown in Figure 1. Confirm if the ECM (PCM) calibration has been updated. If the calibration ID listed is NOT the latest ECM (PCM) calibration — go to step 3.
