TECHNICAL BULLETIN

JTB00426NAS1

'Click' / 'Knock' Noise From Front Seat

XF (X250)

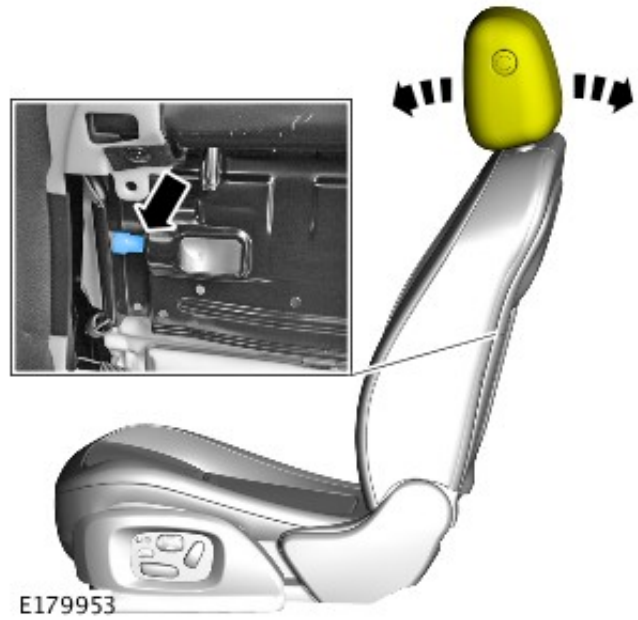
Cause: This may be caused by the end stop block dimension not being within tolerance.

5 Check front seat backrest frame for excessive play in the anti-whiplash plate pivots.

- If no play is found, reverse the removal procedure and continue with diagnosis to determine root cause.
- If excessive play is found, proceed to the next step and replace the front seat backrest.

6 Replace front seat backrest (see TOPIx Workshop Manual, section 501-10: Seating).
