TECHNICAL BULLETIN

JTB00436NAS2

DMTL Pump Water/Ice Ingress

XJ Range (X351)

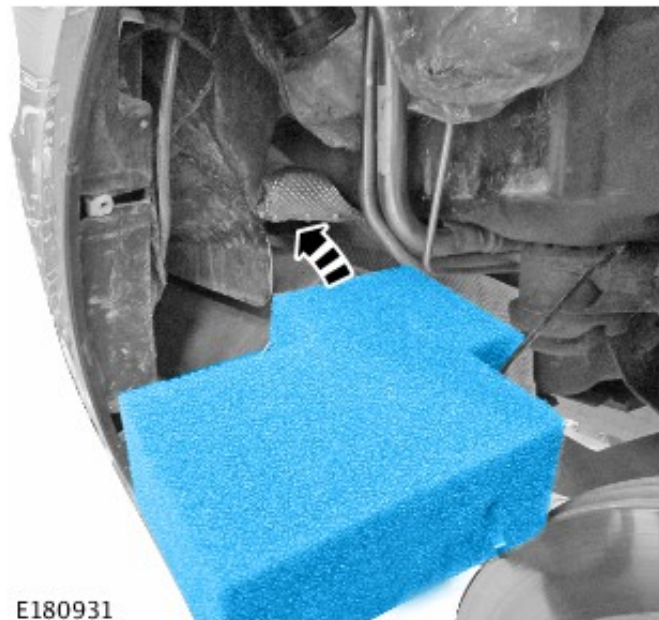
Cause: This may be caused by water/ice, caused by spray from the road tires, becoming trapped within the Diagnostic Module Tank Leakage (DMTL) pump filter.

4 Install the protective foam in the area shown.
