<b>Reference</b>	SSM72460
<b>Models</b>	XJ / X351
<b>Title</b>	X351 XJ Front bumper splitter trim coming adrift
<b>Category</b>	Body
<b>Last modified</b>	08-Oct-2015 00:00:00
<b>Symptom</b>	108000 Ext. Trim/Accessories
<b>Attachments</b>	Front splitter adhesive examples.pdf (Front splitter adhesive examples.pdf)

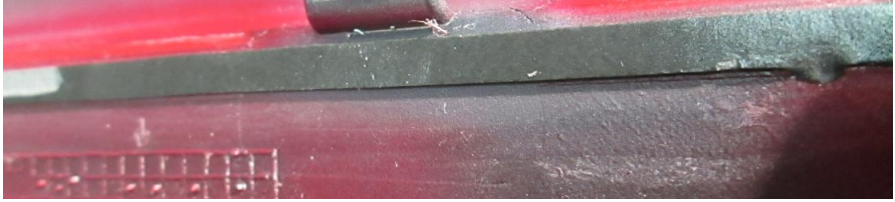
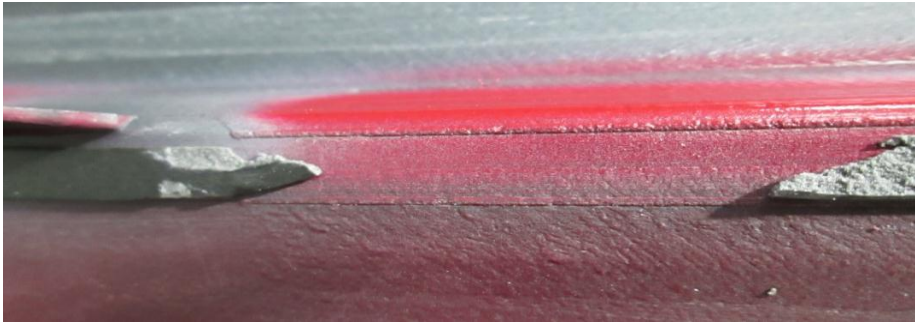
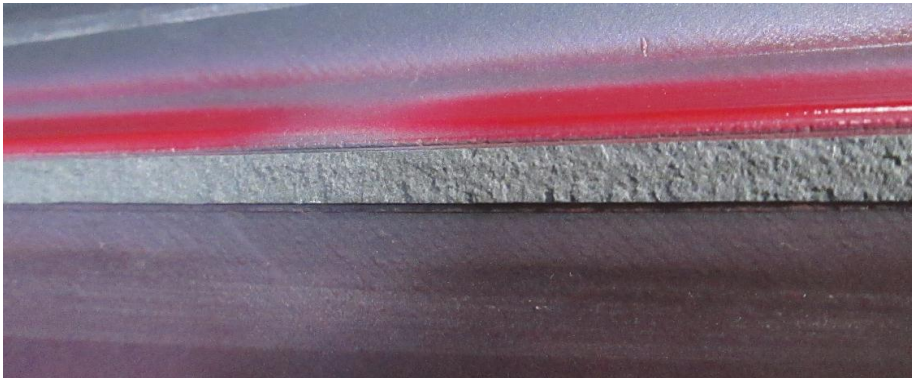
**Content**      **Issue:** On some XJ X351 Models, the front lower bumper splitter trim is working loose and / or coming adrift

**Action:** Should you experience this condition, please submit an ePQR with pictures of the nature of the failure, specifically showing a close up and distance shot of the adhesive strip which retains the trim to the bumper assembly. (Please see attached as an example of the close up pictures required)
