# Program Bulletin

## CUSTOMER SATISFACTION PROGRAM

**SUBJECT:** Exterior Door Handle Binds or Sticks

**MODELS:** 2015 Chevrolet Impala

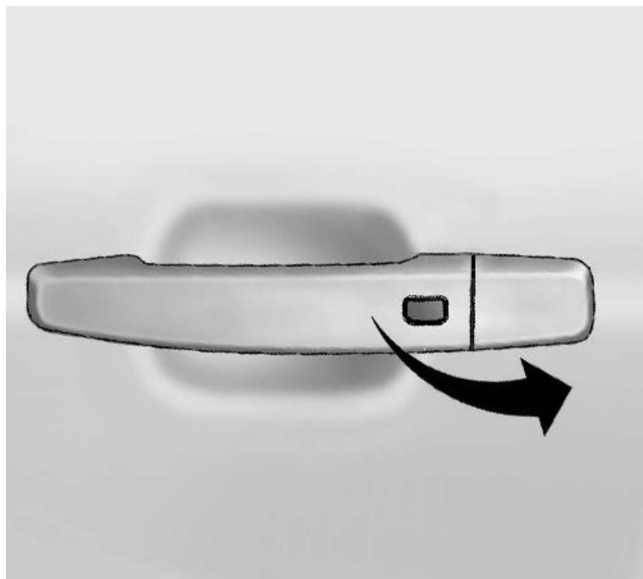
4063151

Direction of pull for door handle inspection.

2. Grasp door handle towards the rearmost edge. Quickly pull the door handle outward and at a rearward angle to check for binding or sticking. Binding or sticking may occur at the maximum travel of the handle.

- 2.1 Repeat five (5) times.
- 2.2 If no problem found, proceed to next handle.
- 2.3 If no problem found on all handles, proceed to Step 4.
- 2.4 If any handle binds or sticks, proceed to Step 3.

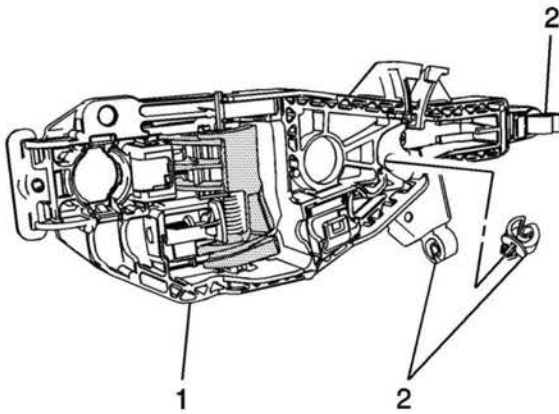
2755846

Door outside handle bracket (1) shown with clips (2), mounted inside door.

3. Replace door handle bracket on binding or sticking handle. Refer to *Front Side Door Outside Handle Bracket Replacement* in SI. For replacement of rear door handle bracket, refer to *Rear Side Door Outside Handle Bracket Replacement* in SI.

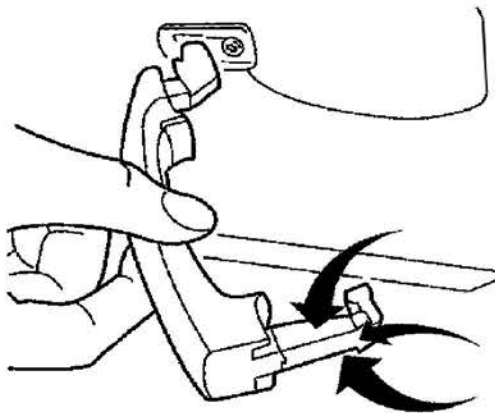
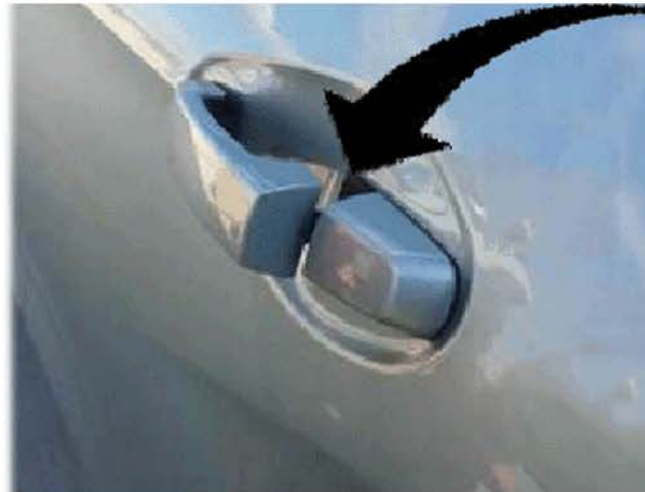
4070469

Lubrication points (arrows) on door handle unpainted black tower leg.  
(Exploded view shown for detail, disassembly not required.)

**NOTE:** A small amount of lubricant should be applied to the black tower leg of the handle. Use only the AC Delco Super Lube Lubricant identified in the Parts Information section. Substitutions are not allowed.

4. Using a Q-tip or suitable applicator, lubricate all door handles, passive or non-passive entry. Thoroughly apply lubricant on top, bottom and rearmost side of the tower leg.

5. Cycle handle five (5) times. Move handle throughout the range of travel, applying light pressure towards front and rear during cycling to work lubricant into the mechanism.
