<b>Subject:</b> <b>LACK OF POWER / WRENCH LIGHT ON / CHECK ENGINE LIGHT ON WITH DTCs P0123 / P0222</b>	<b>Bulletin No:</b> 01-012/15 <b>Last Issued:</b> 06/17/2015
-----------------------------------------------------------------------------------------------------------	-----------------------------------------------------------------

2011-2013 CX-9 with VINs lower than JM3TB\*\*\*\*\*419830 (produced May 1, 2013)

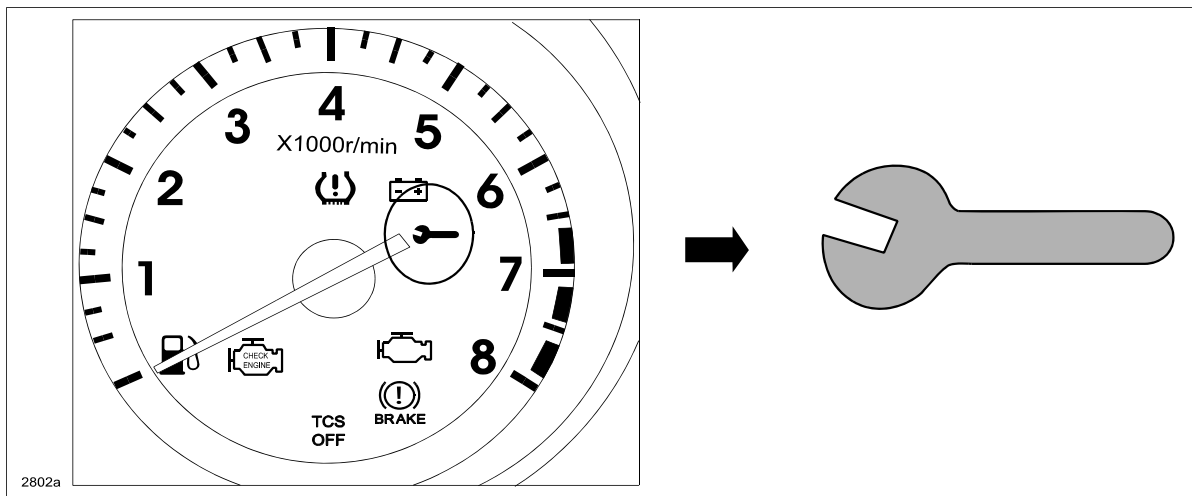
Some vehicles may experience a lack of power and the wrench light comes on with DTCs P0123 / P0222 stored in memory.

Wrench Light: Powertrain Malfunction / Reduced Power Warning Light
