Subject: FRONT DOOR WINDOW AUTO-CLOSING OPERATION INOPERATIVE	Bulletin No: 09-024/15
	Last Issued: 06/02/2015

2007-2012 CX-7

2013-2015 CX-9

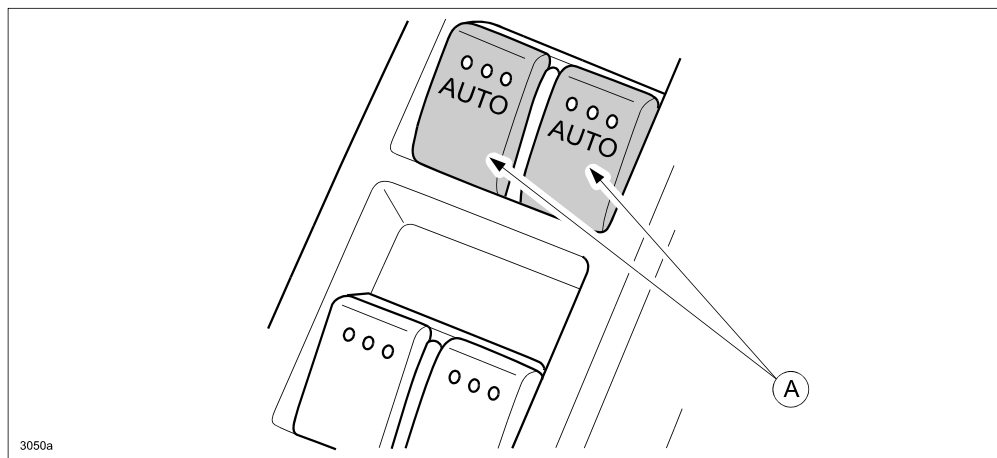
Some customers may experience inoperative front door window auto-closing operation when using the window switches (A). The window moves upward, but automatically returns to the halfway position (as if the jam-safe window function is operating).

The glass run channel may be deformed causing increased sliding resistance against the window glass. This may cause the system to mis-judge that something is blocking the window close movement and operates the jam-safe window function.
