© 2015 Mazda Motor of America, Inc.

Subject: REAR CONSOLE LID IS LOOSE	Bulletin No: 09-023/15
	Last Issued: 6/2/2015

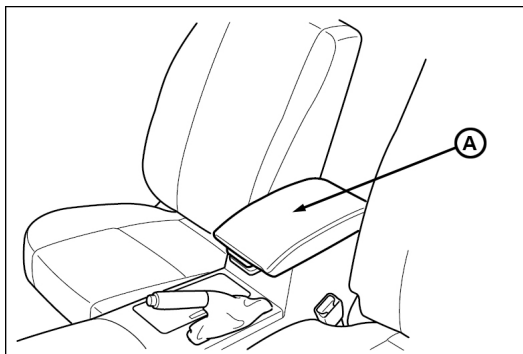
Some customers may complain about a loose rear console lid (A).

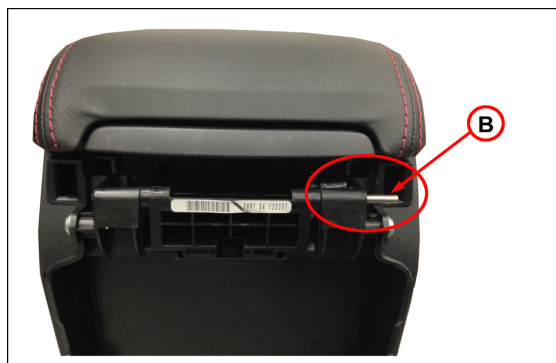
This may be caused by hinge pins coming partially off (B) or completely off.

3. Re-install the rear console lid pin(s) back to the original position.

4. Install a new rear console panel. (See PART(S) INFORMATION)

NOTE: The shape of the rear console panel has been changed, by adding a stopper rib to prevent the pin from coming off.
