<b>Subject:</b> REAR MUDGUARD IS WARPED CAUSING POOR APPEARANCE/NOISE	<b>Bulletin No:</b> 09-028/15
	<b>Last Issued:</b> 07/24/2015

2014-16 Mazda3 (Mexico built) vehicles with VINs starting with 3MZ

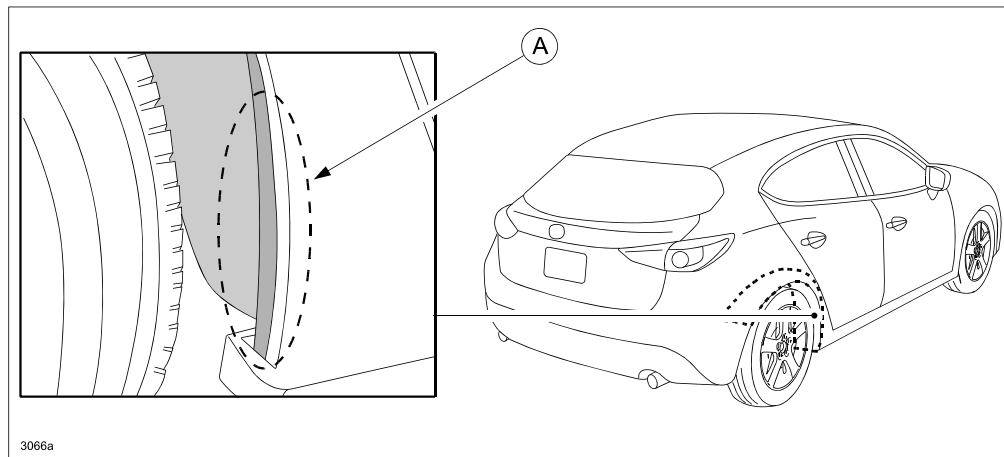
Some vehicles may exhibit a warped rear mudguard with the surface edge (A) visible from outside the vehicle, causing a poor appearance. In the worst case, it could touch the tire and cause a rubbing noise. The deformation is due to product variation.

1. Verify customer concern.
2. Replace mud guards (both sides) with ones used for Japan production Mazda3 (JM1) according to the instructions on MS3 online or the Workshop Manual (section 09-16 MUDGUARD REMOVAL/INSTALLATION).
3. Verify repair.
