© 2015 Mazda Motor of America, Inc.

Subject: UNUSUAL NOISE WHEN STARTING TO MOVE VEHICLE WHILE STEERING WHEEL IS TURNED TO FULL LEFT POSITION	Bulletin No: 06-001/15
	Last Issued: 07/21/2015

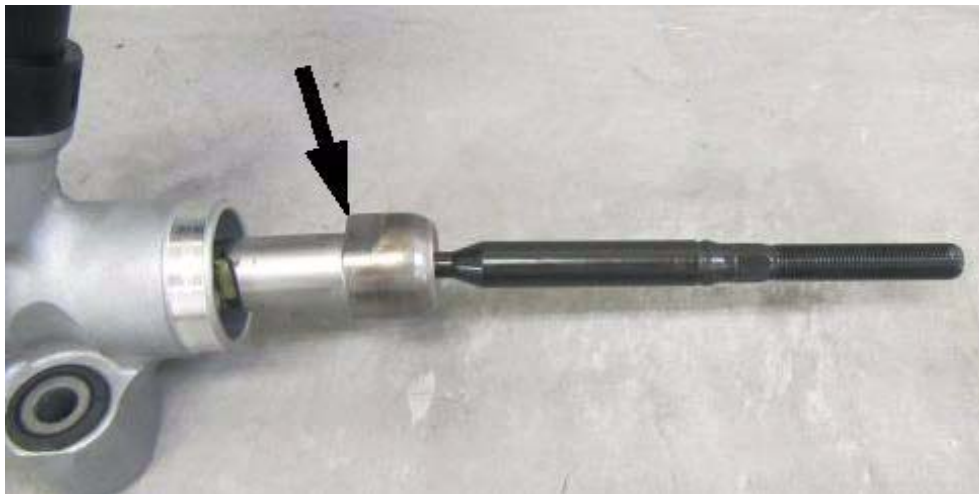
The noise is caused when the edge of the left side inner ball joint gets stuck with the steering gear housing.

To eliminate the noise, the shape of the inner ball joint edge has been changed.
