Subject: ELECTRIC PARKING BRAKE (EPB) WARNING LIGHT ON / EPB WILL NOT RELEASE IN COLD WEATHER	Bulletin No: 04-002/15
	Last Issued: 07/14/2015

2016 CX-5 vehicles with VINs lower than JM3KE*****676325 (produced before June 9, 2015)

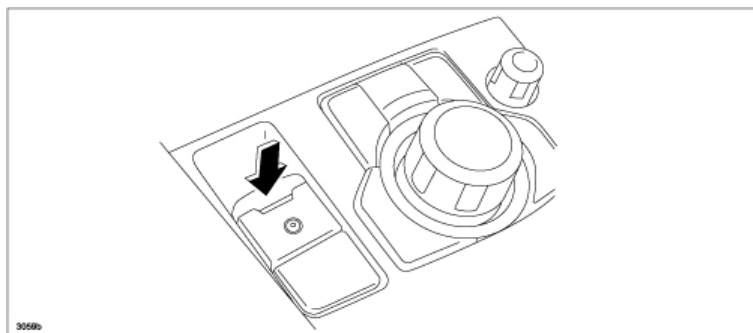
This condition occurs when pressing the EPB switch to release the electric parking brake, however, the EPB will not release.

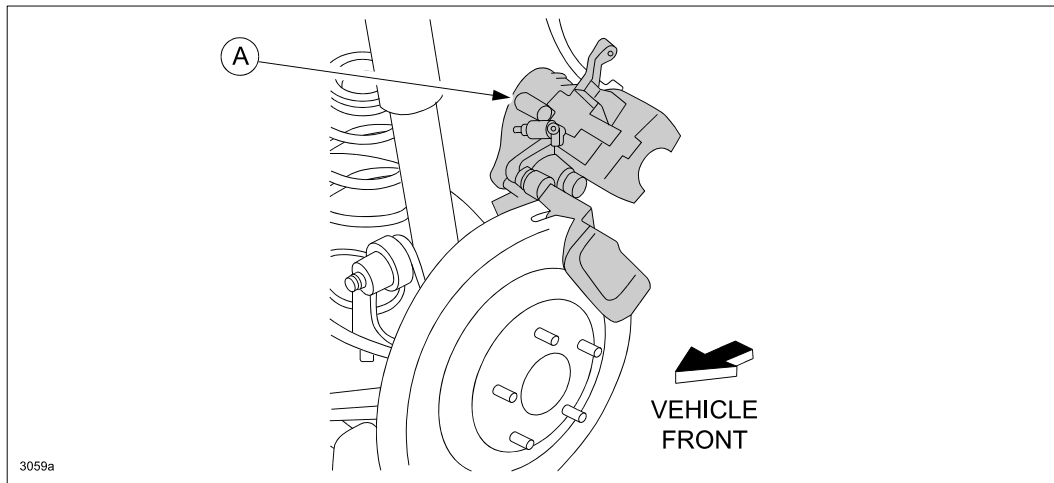
This concern may be caused by the EPB motor gear unit (A) dimensions being out of specification. The machining dimensions of EPB motor gear unit have been improved to eliminate this concern.

1. Verify the customer concern.
 - If DTCs C2005:19 (RH) and/or C2006:19 (LH) are present, proceed to Step 2.
 - If DTCs C2005:19 (RH) and/or C2006:19 (LH) are not present, this bulletin is NOT applicable. Proceed with normal troubleshooting procedures according to MS3 online or the workshop manual.
2. Replace the Electric Parking Brake Motor Gear Unit and Rear Brake Caliper(s) according to the instructions on MS3 online or the Workshop Manual (section 04-12 ELECTRIC PARKING BRAKE MOTOR GEAR UNIT REMOVAL/INSTALLATION and (section 04-11 CALIPER (REAR) DISASSEMBLY/ASSEMBLY).
3. Verify the repair.
