Subject: SQUEAK NOISE FROM WINDSHIELD WIPER LINK	Bulletin No: 09-010/15
	Last Issued: 03/16/2015

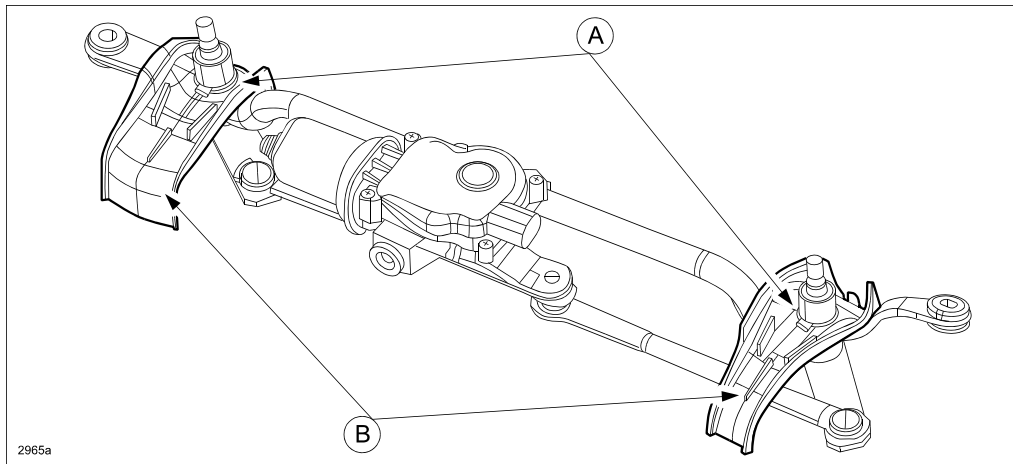
Some vehicles may exhibit a squeaking noise from the windshield wiper link when operating the wipers. This noise may be caused by rust on the sliding parts from water entry through the pivot (A). To prevent water entry, the pivot cover (B) has been enlarged and an O-ring has been added to the pivot.

1. Verify customer concern.
2. If noise occurs when operating the wipers, replace the windshield wiper link assembly with a modified one. Refer to the instructions on MS3 online or the Workshop Manual (section 09-10 WINDSHIELD WIPER MOTOR AND LINK REMOVAL/INSTALLATION).
3. Verify repair.
