00317-01777 Version 4

Excessive Vibration Between 30 and 65 MPH

Supersedes 14-078, dated April 13, 2015, to revise the information highlighted in **yellow**

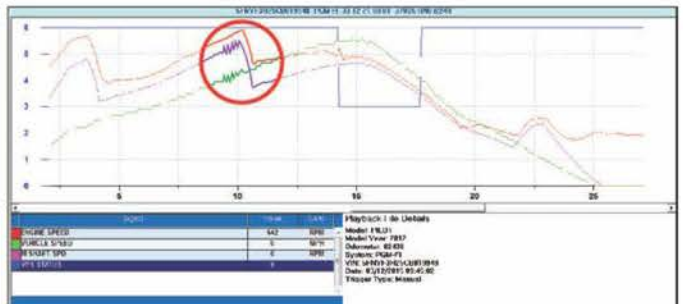
POSSIBLE TORQUE CONVERTER ISSUES

Refer to the Job Aid.

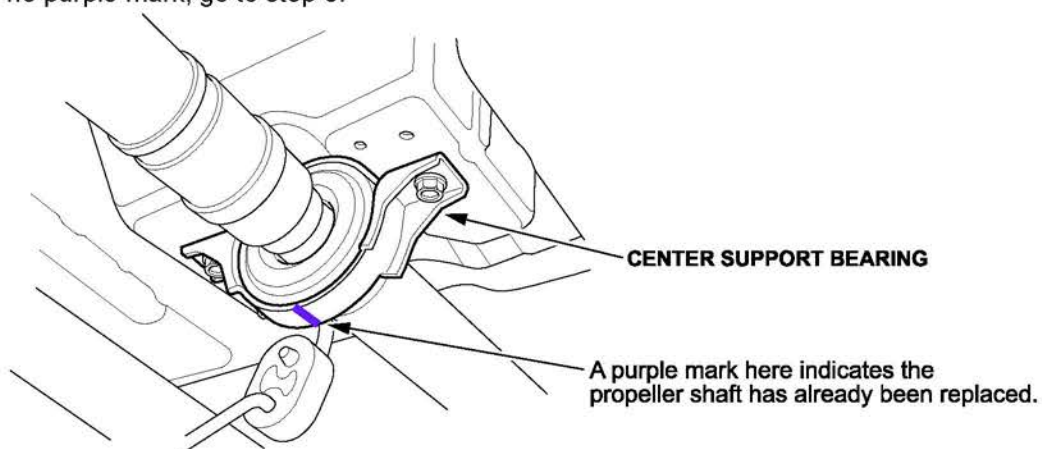
1. Raise and support the vehicle.
2. Check that the propeller shaft has not already been replaced. Check if there is a purple mark on the center support bearing as shown below.
 - If there is a purple mark on the center support bearing, the propeller shaft has already been replaced with a new part. Do not replace the propeller shaft again. If there is still a vibration, this bulletin does not apply. Continue with normal troubleshooting.
 - If there is no purple mark, go to step 3.
