Subject: CORROSION AROUND SPOT WELDS IN TRUNK OPENING	Bulletin No: 09-014/15
	Last Issued: 04/17/2015

2014-15 Mazda3 vehicles with VINs lower than JM1BM*****211783 (produced before May 29, 2014)

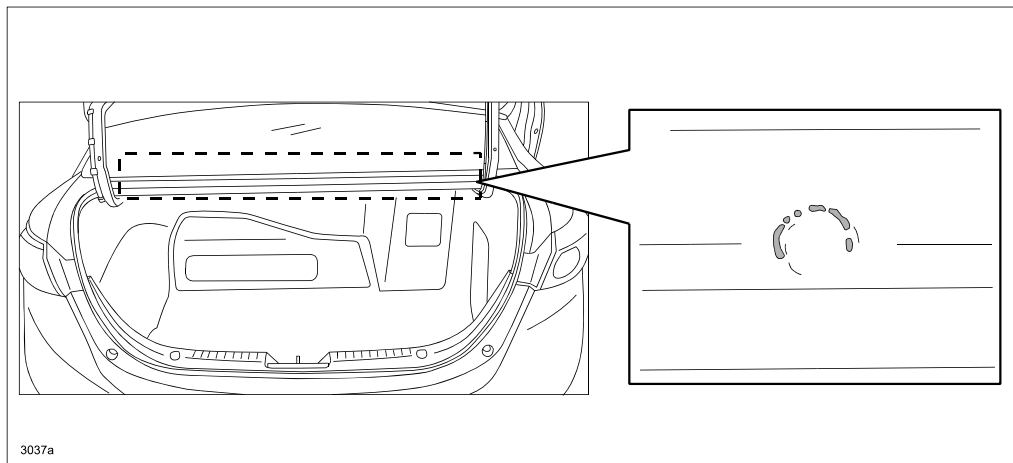
Some vehicles may exhibit corrosion around the spot welds in the trunk opening under the rear window. This is caused by insufficient paint thickness at the spot welds. To correct the problem, the paint thickness has been improved.

1. Verify customer concern.
2. Repair the rust damage on the panel.
3. Verify repair.
