Subject: RATTLE NOISE FROM FRONT DOOR WHEN DRIVING OR WHEN AUDIO BASS IS TURNED UP	Bulletin No: 09-013/15
	Last Issued: 04/17/2015

2010-13 Mazda3

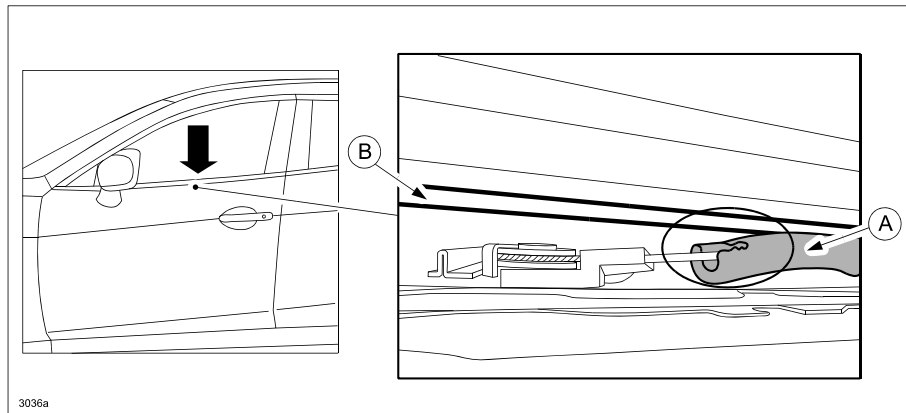
Some vehicles may exhibit a rattling noise from inside the front door when the door vibrates while driving or when the audio system bass is turned up. This is caused by a worn pad (A) on the window regulator cable from repeated operation of the window glass (B) going up and down. The cable then directly contacts the window glass when receiving vibrations, causing a rattling noise.

4. Remove the front window regulator from the vehicle according to the instructions on MS3 online or the Workshop Manual (section 09-12 FRONT WINDOW REGULATOR REMOVAL/INSTALLATION).
5. Cut off the damaged part of the window regulator cable pad and then add urethane foam from the Noise Parts Kit to fill.
6. Install the removed parts in the reverse order.
7. Verify repair.
