**November 6, 2015**

02635 Version 2

## Safety Recall: Rear Grab Handle Brackets

This bulletin supersedes S/B 15-079, dated October 23, 2015, to include the Repair Procedure, Parts Information, and Warranty Claim Information

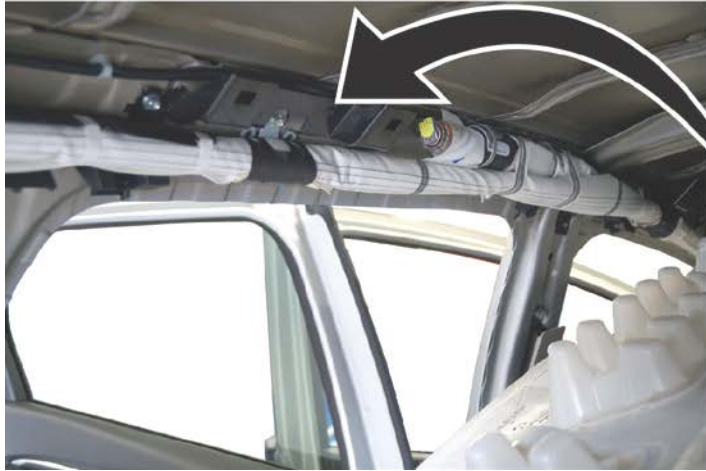
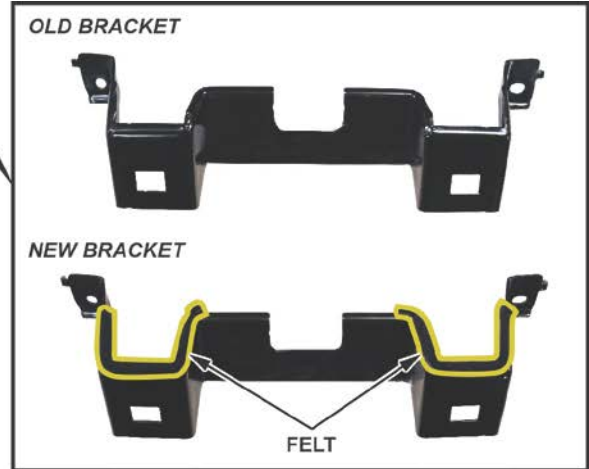
Certain 2015–2016 model year Honda Fit vehicles were equipped with a rear grab rail bracket that was not manufactured to design specifications and may interfere with side curtain airbag deployment. In the event of a collision, if the side curtain airbag does not deploy as designed, the vehicle may fail to comply with the requirements of FMVSS 214, FMVSS 226, and the risk of injury is increased.

2. Replace the rear grab handle brackets and torque the bolts to **4.4 N·m (3.2 lb-ft)**.

NOTE: Make sure you install the new grab handle brackets in the correct direction.
