<b>Subject:</b>  NOISE FROM FRONT DOOR CHECKER AREA	<b>Bulletin No:</b> 09-005/15
	<b>Last Issued:</b> 02/04/2015

2013-2014 CX-5 vehicles with VINs lower than JM3KE\*\*\*\*\*398378 (produced before October 1, 2013)

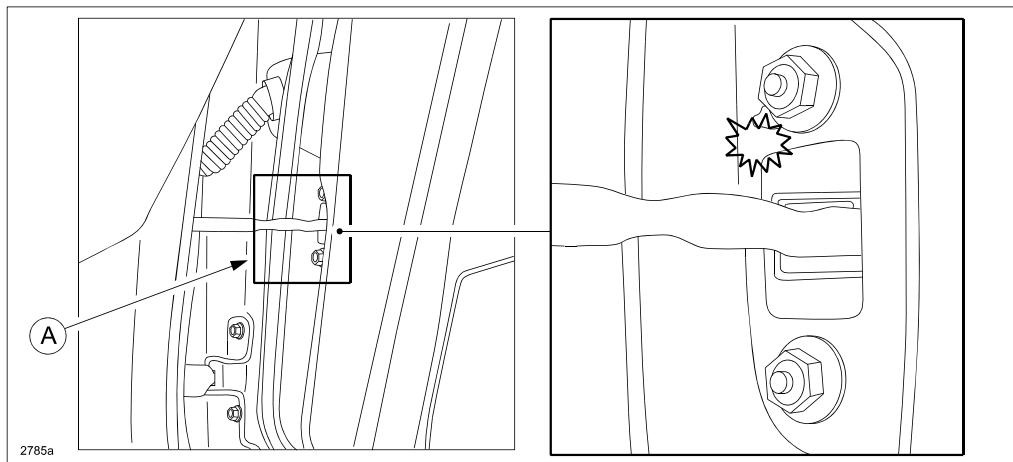
Some vehicles may experience noise from the front door checker installation location (A) whenever the door is opened. When the door is fully opened, the door checker may become over-stroked and cause a crack at the spot welding area around the door checker.

To eliminate this concern, the thickness of the hinge reinforcement has been increased.

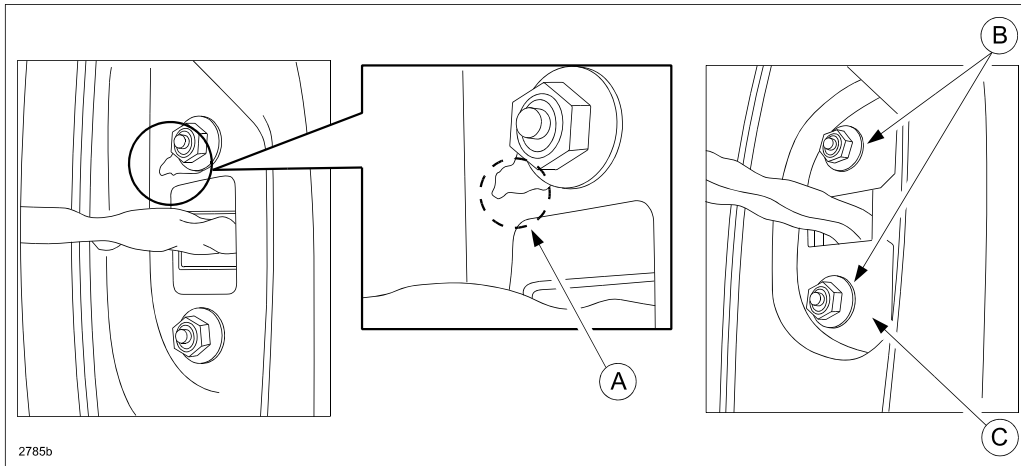
1. Verify the customer concern.
2. Inspect the body panel welding point (A) on both front doors.
  - If no cracks are found on the body panel, this service bulletin does not apply. Refer to the online instructions on MS3 or the Workshop Manual (Section 09 - Body and Accessories) for further troubleshooting.
  - If the body panel is cracked, repair it according to the steps below:

- a. Apply approx. 0.3 ml grease per side (using either molybdenum grease or lithium grease) on the welding point (A) (cracked area).
- b. Install plate (C) (checker reinforcement) on the body panel.  
**Tightening Torque (B): 71-106 in•lbf {8-12 N•m, 82-122 kgf•cm}**
- c. Repeat the repair on opposite side front door.

- a. Remove all corrosion found on the body panel.
- b. Apply primer to the repaired surface.
- c. Apply touch up paint to the repaired surface.
- d. Install plate (C) (checker reinforcement) on the body panel.  
**Tightening Torque (B): 71-106 in•lbf {8-12 N•m, 82-122 kgf•cm}**
- e. Repeat the repair on opposite side front door.
