Service Bulletin

ct:	AIR TEMPERATURE WILL NOT CHANGE	Bulletin No:	07-003/15
		Last Issued:	02/04/2015

2014-15 Mazda3 (with manual A/C)

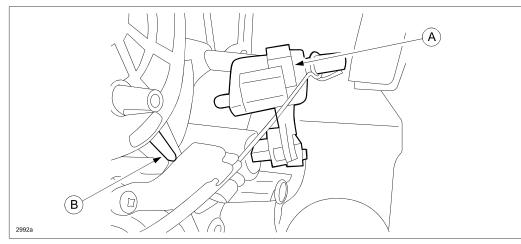
Some customers may complain about that air temperature from the air conditioner will not change by the air temperature control knob, and may be accompanied by some rattle noise from inside of the dash board. This concern may be caused by the temperature control link being pulled out of the HVAC housing. To correct the problem, the temperature control link has been modified.

- 1. Verify customer concern.
- Refer to the instructions on MS3 online or the Workshop Manual (section 07-40 CLIMATE CONTROL UNIT REMOVAL/INSTALLATION [MANUAL AIR CONDITIONER) and check that the MIX LINK (Air mix link/Temperature control link) (A) is properly connected to the MIX DOOR CRANK (B) and works while rotating the temperature control knob.

- a. If it works, this Service Bulletin does not apply. Refer to the instructions on MS3 online or Workshop Manual for troubleshooting and repair.
- b. If the MIX LINK is detached, proceed to the next step.
