<b>Subject:</b> <b>TPMS WARNING LIGHT ON AFTER RECALL CAMPAIGN 8014J</b>	<b>Bulletin No:</b> 02-002/15
	<b>Last Issued:</b> 01/23/2015

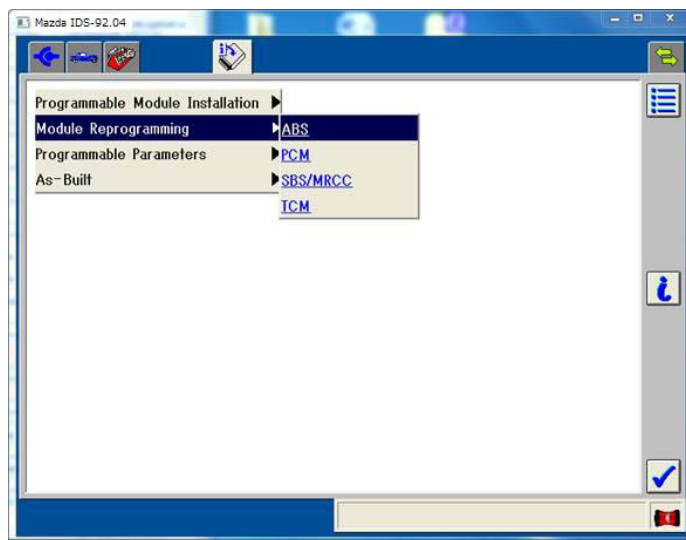
1. Verify that the recall campaign 8014J is closed for the vehicle.
2. Reboot the IDS to clear memory before reprogramming.
3. Using IDS 93.03 or later software, reprogram the ABS module to the latest calibration following the "Module Reprogramming" procedure.
  - a. Select "Module Reprogramming", then select "ABS".

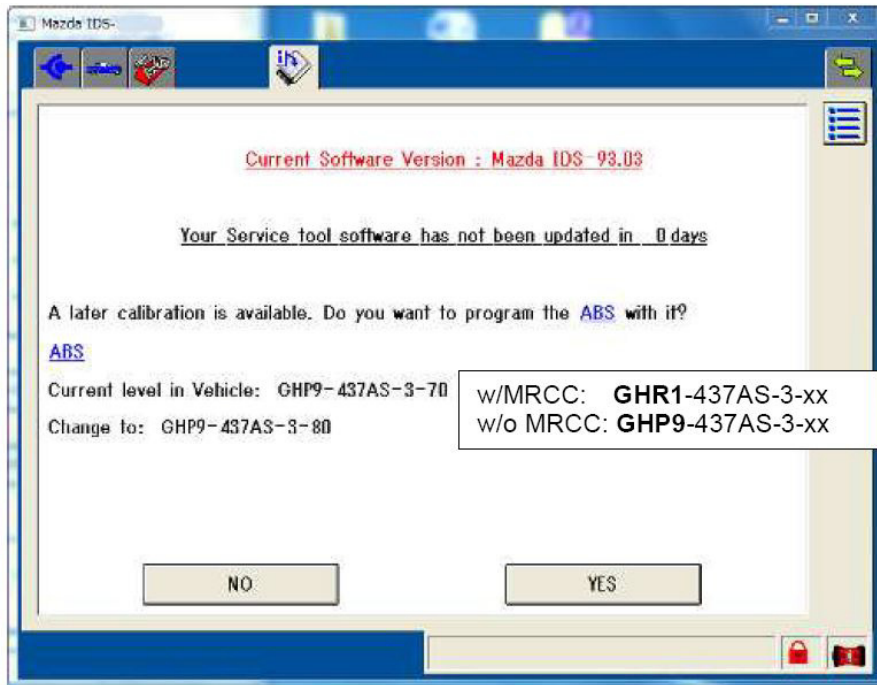
b. The following screen will be displayed:

Click "YES" and follow the M-MDS instructions to reprogram the ABS module.

If the message "No later calibration is available on the system for this ABS" is displayed, the ABS module is already at the latest calibration. "Current level in Vehicle" will show GHR1-437AS-3-80 or GHP9-437AS-3-80. This service bulletin does not apply.

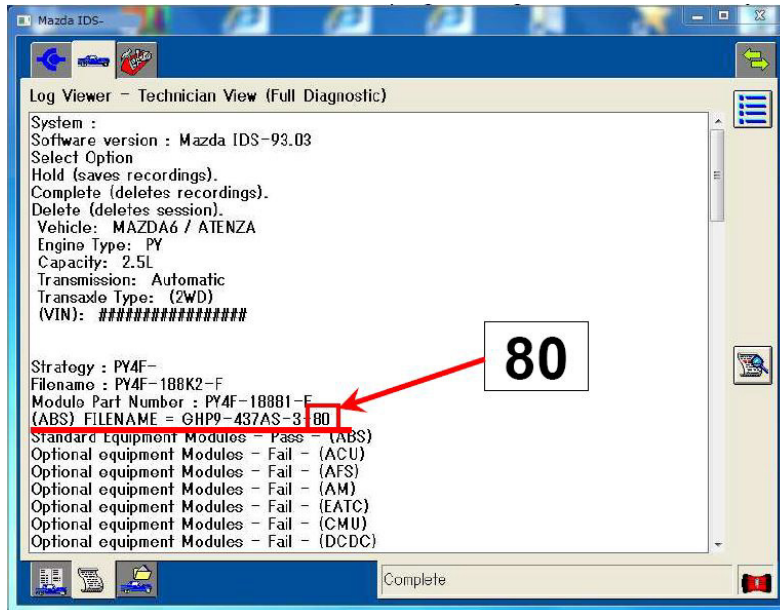
- c. After reprogramming, remove the session. Then, open a new session again and go to the “Log Viewer” screen on which the programmed file name is displayed as shown in figure below. If the last two letters are “80” or later, the reprogramming has been successfully completed.
