Subject: CREAKING NOISE FROM FRONT LOWER CONTROL ARM BUSHINGS	Bulletin No: 02-001/15
	Last Issued: 01/14/2015

APPLICABLE MODEL(S)/VINS

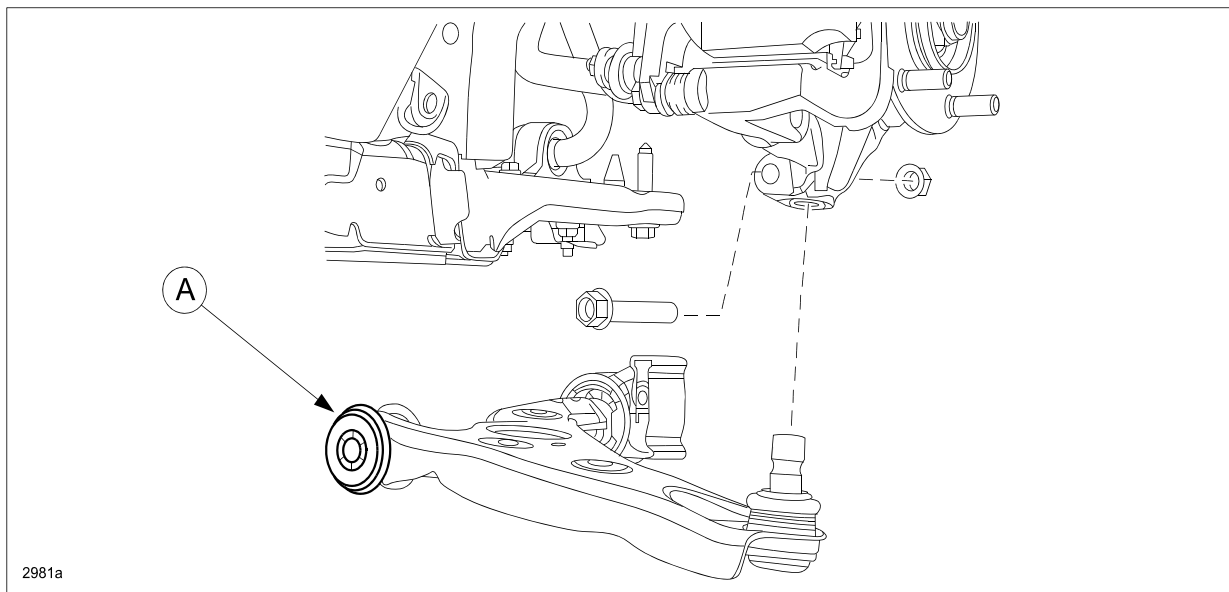
Some vehicles may exhibit a creaking noise from under the front of the vehicle when driving over bumps. The noise occurs at approx. 12 - 25 mph (20 - 40 Km/h) when the road surface is wet or after a car wash. The noise becomes more noticeable when driving over higher bumps.

The creaking noise is caused when the front lower control arm bushing(s) (A) become wet.

1. If possible, verify the customer concern when driving over bumps under wet conditions.
2. Replace front lower control arm bushing with new service part according to Steps 3 - 8.
3. Remove the front lower control arm according to the on-line instructions on MS3 or the Workshop Manual (section 02-13 FRONT LOWER ARM REMOVAL/INSTALLATION).
4. Remove the front lower arm bushing using SSTs 49 G030 797 and 49 B025 004.
5. Place the SSTs on the front lower control arm as shown below, then press out the bushing.
