<b>Subject:</b> RATTLE, SNAP, POP OR CRACK NOISE FROM BOTTOM OF A-PILLAR	<b>Bulletin No:</b> 09-003/15
	<b>Last Issued:</b> 01/14/2015

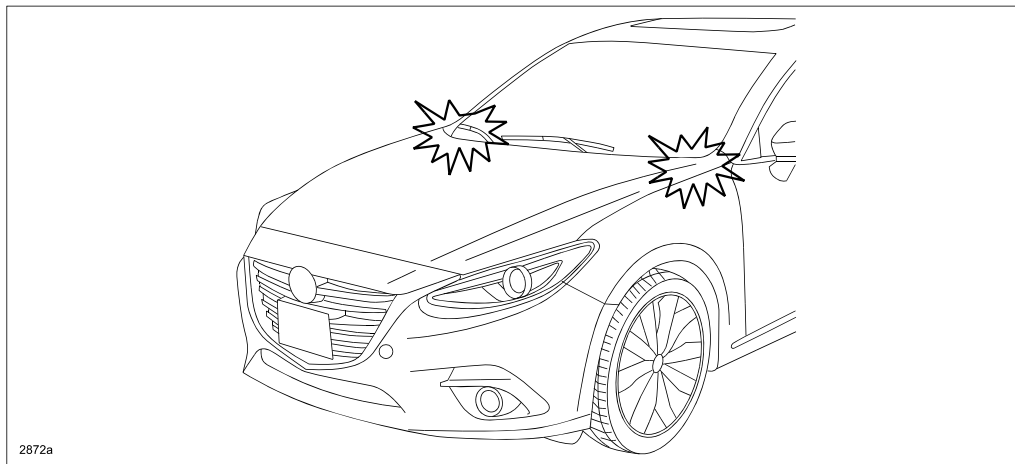
Some vehicles may exhibit a noise from the bottom of the A-pillar when driving on rough roads or over bumps. This is caused by the cowl upper plate and/or dash upper panel interfering with the wiper bracket. For the affected vehicles, a clearance needs to be created between the wiper bracket and cowl upper plate and between the wiper bracket and dash upper panel. To correct the concern, additional sealing and welding have been applied to the wiper bracket.
